Reach GL02, GL03, GL04

Reach GL02

Existing Conditions

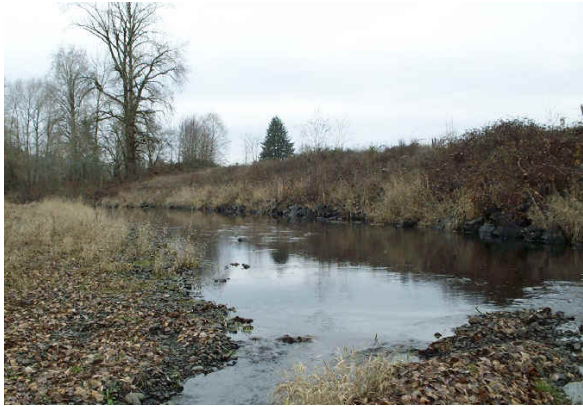
Photo GL02-1

- *Riparian Conditions:* A majority of the riparian area is in moderate to poor condition with stands that are narrow and fragmented. The width varies from 0 feet to 250 feet. The stream runs west to east for a significant length of the reach. Much of the right bank (south side) has been protected with riprap. Some alders have grown through the riprap, but this is the only row of trees between the adjacent access road and the creek. There is very little effective shading along this approximately 800 foot stretch. There is approximately 500 foot stretch with no riparian vegetation along the left bank. This bank was protected with riprap after the 1996 flood.

Looking upstream (northeast) on Gales Creek. Riprap bank is void of native shrubs and trees. Planting and maintenance of native riparian trees and shrubs, through the riprap, will improve stream shading along this bank. Planting of coniferous trees along the top of bank will also improve shading and will provide a source of LWD in the future.

1. Work with the landowner to plant riparian vegetation along approximately 500 feet of the left bank where riprap was placed after the 1996 flood. Enhance the approximately 800-foot long riparian zone along the right bank, where riprap was placed after the 1964 flood.

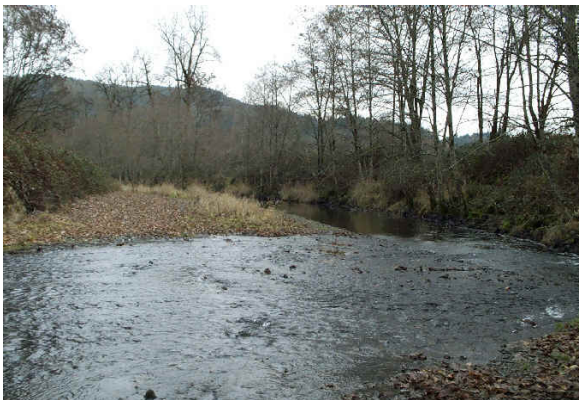
Photo GL02-2

Looking downstream (southeast) on Gales Creek. The right bank has alders growing through riprap that was placed after the 1964 flood. Removal of a short section of riprap and placement of a log vane will provide opportunities for the development of a scour pool.

2. Work with the landowner to enhance the remaining riparian areas through the planting of additional trees for stream shading.
3. Increase the in-stream complexity of the channel through the placement of LWD. Review with the landowner the potential of removing a short (approximately 50 feet) section of riprap and placing log vanes or some other form of wood debris that would help to form a scour pool. A specific location would be determined after discussions with the landowner and evaluation by a geomorphologist during the project design phase.

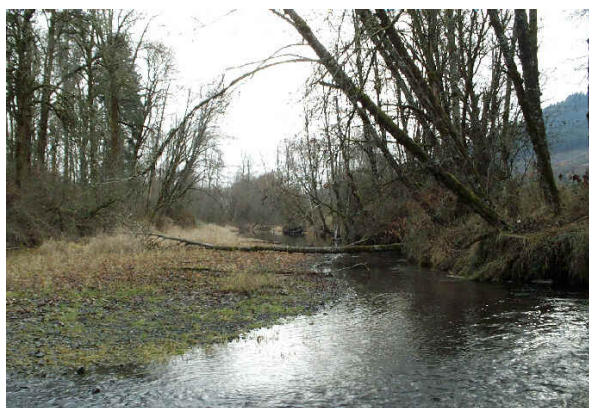
Photo GL03-1

- *Riparian Conditions:* A significant riparian area exists along the left bank. It varies in width from 75 feet to approximately 600 feet. However, this area is dominated by smaller trees (typically alder and some ash), with a few interspersed cottonwood trees. The 2002 aerial photo shows that the trees along the left bank provide excellent morning shade. Shrubs dominate the riparian area along the right bank, with only a narrow (approximately 25 feet) band of alders near the upstream end of the reach. Therefore, the riparian area along the right bank would provide poor afternoon shading. Non-native shrub species such as Japanese knotweed and reed canarygrass dominate the shrub community.

Looking downstream (south) on Gales Creek. Riparian enhancement in this area with both conifer and deciduous trees would improve stream shading along the west bank. This photo taken in late autumn of 2002 shows low water flow conditions.

1. Work with the landowner to secure a conservation easement for the large riparian area along the left bank. Plant additional cottonwood trees and remove non-native vegetation within this area.
2. Work with the landowner to enhance the riparian areas along the right bank through the planting of additional trees for stream shading.

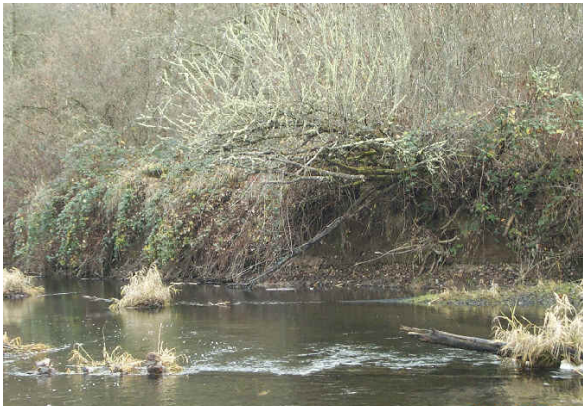
- *Channel Conditions:* 50- 70 percent of outside banks are eroding with 40-50 percent having vertical banks. Average height of eroding banks is approximately 6 feet. Review of the 2002 FSA slides and 1994 aerial photo reveals that sinuosity has decreased through the loss of two meanders in the lower half of the reach. This has resulted in a loss of stream length of approximately 100 feet. Therefore, the stream gradient has increased within the last 8 years. The gradient of the stream within the reach is approximately 0.3 percent. The valley slope is approximately 0.5 percent.

Photo GL04-1
Looking downstream (southeast) on Gales
Creek. Note the eroding bank and growth of
Himalayan blackberries.

1. Work with the landowner to secure a conservation easement for the large riparian areas along the left and right banks. Plant additional cottonwood trees and remove non-native vegetation within this area.
2. This reach is highly dynamic, as seen on the aerial photo, by the change in the channel location between 1998 and 2002. The outside bank is eroding along much of the reach. There is an extensive riparian area adjacent to the eroding bank so it is not endangering any structures. Access would be difficult for any equipment required to stabilize the bank. Therefore, it is recommended to let the stream self adjust within this reach.
