## Reach GL05, GL06, GL07

## Reach GL05

## Reach GL06

## Reach GL07

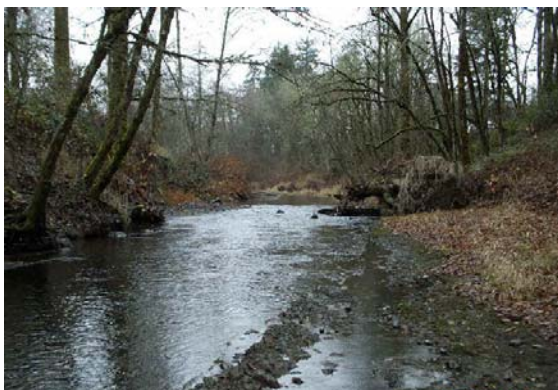
**Photo GL05-1**

- *Habitat Elements:* No formal habitat survey was completed. There has been channel scour down to bedrock (cemented sandstone) throughout the reach. The stream channel has a U shape. The reach exhibits primarily riffle/glide habitat features. No significant pools were observed in the reach. LWD volume is extremely low. There is only one significant root wad that is in the high flow channel.

**Looking upstream (north) on Gales Creek above Roderick Road Bridge. The bed has been scoured down to cemented sandstone in most of the reach. Also, the channel lacks LWD. Intact riparian forest areas are shown on both banks in this photo taken in late autumn of 2002.**

1. Work with the landowner to secure a conservation easement for the large riparian area along the right bank and the riparian area between the creek and Gales Creek Highway along the left bank.
2. Increase the in-stream complexity of the channel through the placement of LWD. This work should be completed all along the reach so that small pools and riffles form and provide habitat diversity. The wood will have to be well anchored due to the confined nature of the channel and the related high flow velocities. Specific location for structures and methods to anchor the wood will be determined during the project design phase.

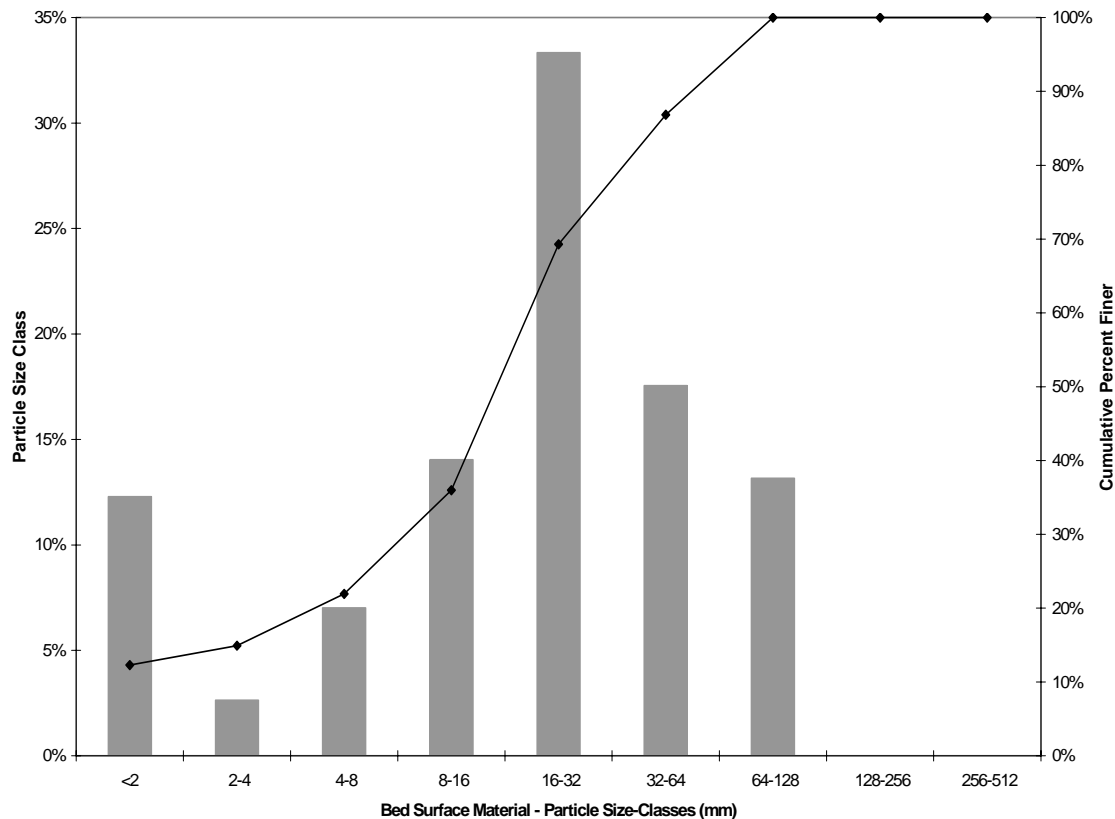
**Figure 4-6:** Particle Size Class Distribution at the Tail Out of Roderick Road Pool

overhanging the creek. However, because of the channelized nature of the reach, LWD may get washed out during high flows. There are 2 riffles within the reach. Cross-sectional data was gathered at the upstream riffle, which is just downstream of the bridge. A Wolman pebble count was completed at this location. Substrate samples were collected at 1-foot intervals along a cross-section that extended from the top of left bank to the top of right bank. Figure 4-6 shows the particle size class distribution of substrate material found at this location. As shown in the figure, sand and silt particles (<2mm) make up approximately 13 percent of the particles.

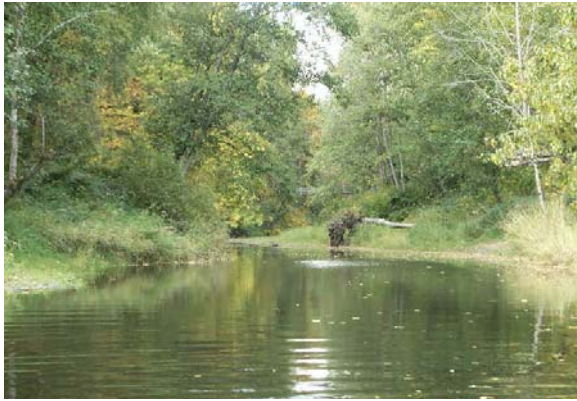
**Photo GL06-1**

**Looking upstream (north) on Gales Creek from a location about 800 feet downstream of the Roderick Road Bridge. Stream channel lacks some large woody debris. Existing riparian areas with predominately deciduous trees are shown on both banks in this photo taken in autumn of 2002.**

2. Increase the in-stream complexity of the channel through the placement of LWD. The work would consist of creating areas with large wood and deep pools that fish can utilize for refuge from high water temperatures. This work should be coordinated with any work that is completed to enhance use of the floodplain along the left bank. Wood in the stream could be used to back water up onto the floodplain, or into a backwater channel. Specific activities will be determined during the project design phase.
3. Work with property owners near the creek to educate them about programs that promote stream stewardship and that are available to agricultural operations through state and federal grants.

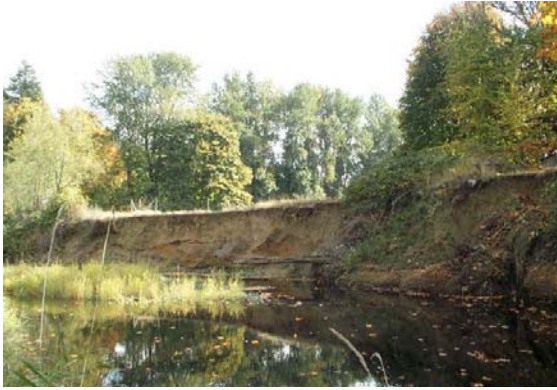
**Photo GL07-1**

- *Channel Conditions:* This reach is predominately confined. The average floodplain width during the 1996 flood was approximately 150 feet. The bankfull width is approximately 100 feet. There is extensive bank erosion along the upstream portion of the reach. It is mainly along the right bank, but some exists along the left bank near the upstream portion of the reach. The channel location has not changed significantly between 1994 and 2002. However, it is suspected that the bank erosion near the upstream portion of the reach, has led to the introduction of a significant amount of LWD, which in turn has led to the creation of a new meander bend. Approximately 25-35 percent of the outside banks are actively eroding. The average height of eroding banks is approximately 8 feet. The gradient of the stream within the reach is approximately 0.2 percent. The valley slope is approximately 0.4 percent.

**Looking downstream (southeast) on Gales Creek at the right bank. Active bank erosion is visible. Bank terracing and riparian enhancement would provide additional shading for the stream.**

1. Determine the status of the Washington County easement for the significant riparian area along the left bank. Develop an agreement with the County to either terrace back the left bank to enhance the floodplain or create a backwater channel in order to provide refuge for fish during high flow conditions. This should occur across from Peacock Lane. This would allow the channel to more easily access the floodplain along the left bank and will take pressure off the eroding bank at this location. Existing riparian vegetation would be protected as much as possible and any impacted banks would be revegetated with native trees that provide shade for the creek.

2. Work with the landowners along the right bank to restore the riparian zone.
3. Increase the in-stream complexity of the channel through the placement of LWD. This work should initially concentrate near Peacock Lane so as to back water into any floodplain enhancements along the left bank. The work would consist of creating areas with large wood and deep pools that fish can utilize for refuge from high water temperatures. Specific activities will be determined during the project design phase. There was an existing woody debris jam in this area. Check to see if it remained during the high flows of early February 2003.
4. Work with property owners near the creek to educate them about programs that promote stream stewardship and that are available to agricultural operations through state and federal grants.
