Reach GL08, GL09, GL10

1998 Aerial Photo Map

Reach GL08

Existing Conditions

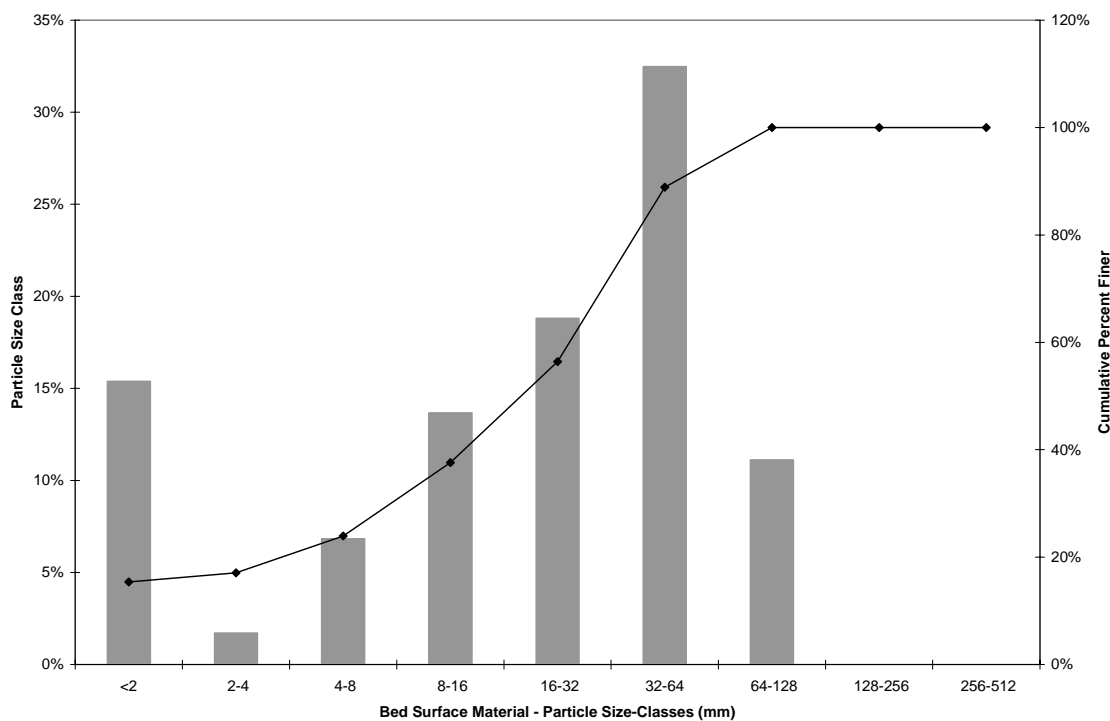
Figure 4-7: Particle Size Class Distribution at the Tail Out of Green Gables Pool

The Oregon Stream Habitat Survey sheet was filled out for a cross-section taken in the middle portion of the reach, at the tail out of the Green Gables pool. The results are presented in Table 4-7.

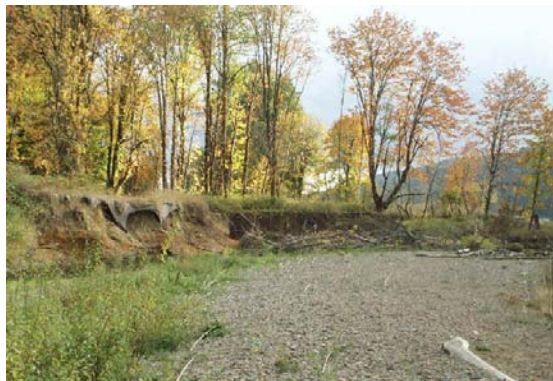
Photo GL08-1

- *Riparian Conditions:* The riparian area along the left bank is in good condition with a width of 300 – 600 feet. The left bank is actively eroding and there has been good LWD recruitment. The riparian area along the right bank is in poor condition. About 50 percent of the bank is devoid of any shrubs or trees. The recruitment potential for the reach is moderate, with there being a much higher potential along the left bank than the right bank. There is poor shading along a majority of the reach.

Looking downstream (south) at left bank of Gales Creek (meander bend that is just upstream of the confluence of Roderick Creek and Gales Creek). An extensive gravel bar with some vegetation is shown at center. Active erosion along the outside bank is visible in this photo.

1. Work with landowner to secure a conservation easement for the large area along the left bank.
2. Work with the landowners along the right bank to restore the riparian zone.
3. Work with landowner to increase sinuosity of channel along left bank, upstream of meander bend that is located just upstream of the confluence of Roderick Creek and Gales Creek. This work would be

completed to help reduce the energy being imparted on the outside bend, along the left bank, on the upstream side of the meander bend.

Increasing the sinuosity can be beneficial by reducing flow velocities and forcing the channel to change directions, thus losing energy. Specific activities will be determined during the project design phase.

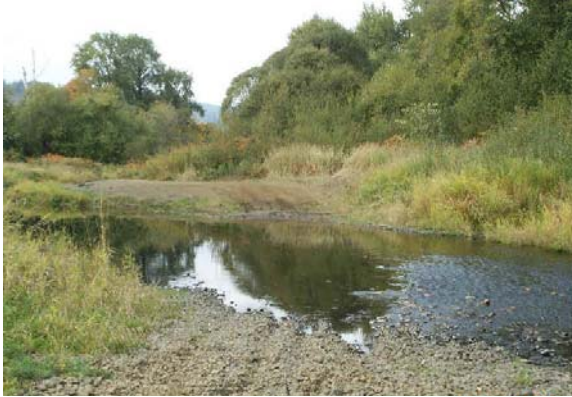
- *Riparian Conditions:* There are moderate to poor riparian conditions along this reach. This is partly caused by illegal vehicular access. Driving over the gravel bars does not allow for shrubs to grow on the upper portion of the bar. Much of the riparian vegetation adjacent to the creek is non-native grasses (reed canarygrass) and Japanese knotweed. This does not provide adequate shading. The riparian width varies from 60 feet to 600 feet. Wider riparian areas are often fragmented and do not have a significant number of trees close to the edge of the creek. The recruitment potential for LWD is low due to the fact that many of the larger trees are 50 – 100 feet from the edge of the creek. Alder is the most populous tree along the reach. There is some Oregon ash, a few cottonwood but no conifer trees.

- *Habitat Access:* No natural or structural passage barriers were observed along this reach.
- *Habitat Elements:* No formal habitat survey was completed. The channel contains predominately riffle/glide habitat with few pools. The reach has a high degree of sediment in the glides and pools and a moderate degree of sediment embeddedness in the riffles. When walking in the glide areas, the substrate felt soft, indicating the lack of gravels/cobbles substrate in the glides. This reach has a much higher degree of sediment substrate than the upstream reaches. The LWD volume is low. Illegal access to this reach by individuals driving 4-wheel drive vehicles in the creek has severely degraded the functions of this reach. There are multiple gravel bars where vehicle

traffic has stunted vegetation growth. In locations where vegetation has grown back, it is typically non-native species such as reed canarygrass and Japanese knotweed. It appears that vehicles driving in the creek have contributed to channel widening, which has led to shallow summer flow depths and potential thermal loading increases.

Photo GL09-1
Looking north across Gales Creek. Tracks from recent illegal vehicular traffic in the creek channel are visible at the center of photo.

3. Work with the landowners to stop people from illegally driving in the stream. The main access point is located near the downstream end of the reach along the right bank. Either install a gate with lock if the landowner desires access to the edge of the creek, or place large boulders at the access point to prevent people from illegally accessing this area. Driving in the creek channel has adversely impacted the creek by causing the channel to widen, which has led to shallow summer flow depths. After stopping the illegal access, develop a project to increase the in-stream complexity of the channel through the placement of LWD. This work should initially concentrate near the middle of the reach where the illegal access occurred. The work would consist of creating areas with large wood and deep pools that fish can utilize for refuge from high water temperatures. Specific activities will be determined during the project design phase.

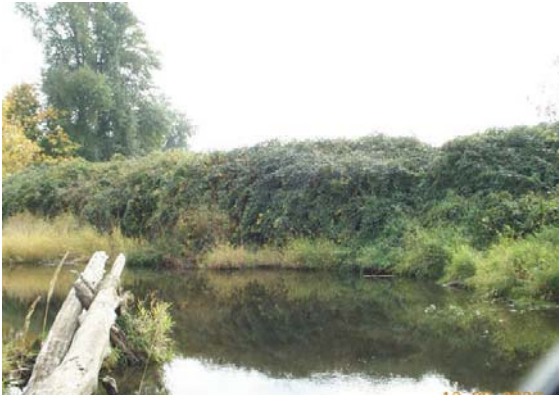
Photo GL10-1

- *Riparian Conditions:* Poor shading is provided by riparian vegetation. The riparian width varies from 0 feet to 300 feet. Wider riparian areas are often fragmented and don't have a significant number of trees close to the edge of the creek. The recruitment potential for LWD is low due to the fact that many of the larger trees are 50 – 100 feet from the edge of the creek. The Himalayan blackberries are thick along 80 – 90 percent of the banks. This tends to reduce the potential for growth of native shrubs or trees adjacent to the creek. Alder is the most populous tree along the reach. There is some Oregon ash, a few cottonwood and no evergreen trees.

Looking downstream (south) at the right bank of Gales Creek. The stream bank is covered with non-native species such as Himalayan blackberry and reed canarygrass. Riparian enhancement would provide increased shading.

1. Work with the landowners along the right bank to enhance and restore the riparian zone. This involves the removal of non-native species (mainly Himalayan blackberry) and planting of native vegetation.
