Gales Creek Fish Passage Assessment and Prioritization

Washington County, Oregon

February 2014

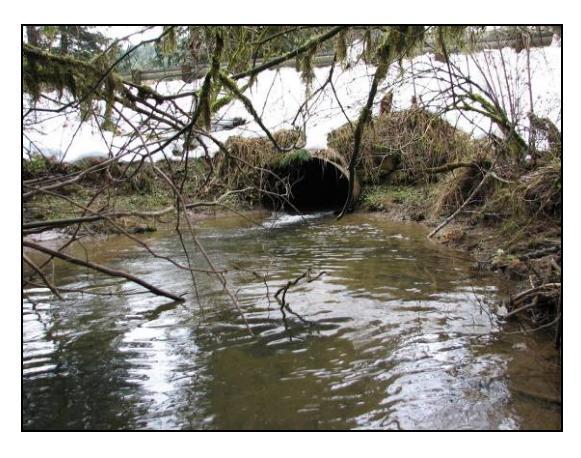
West Fork Beaver Creek

Examples of High Priority Barriers

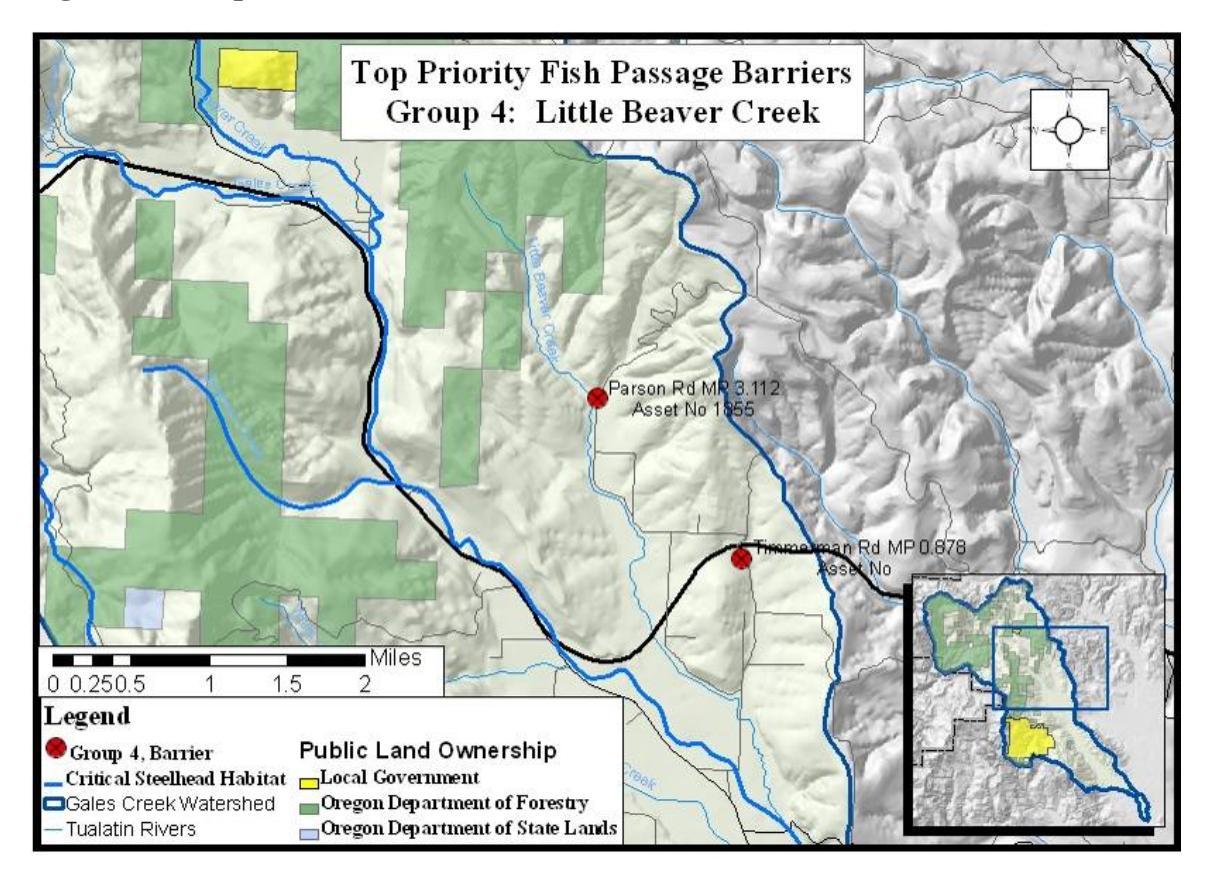
Figure 8. Group 4: Little Beaver Creek Barriers

Culver	rt Location	Culvert Key # 340015FD7C Group 4
Road Name	Parson Rd	
Milepost	3.112	
Watershed	Gales Creek	
Stream Name	Trib to Little Beaver Creek	
Latitude	45° 38.038' N	· · · · · · ·
Longitude	123° 14.251' W	think with a start with a start
Culvert Key #	340015FD7C	
County Asset #	1855	
Culvert	Information	
Shape	Circular	
Material	Structural Steel Plate	
Length (ft)	32	
Width (ft)	3	
Height (ft)	3	
Outlet Perch (ft)	0.58	Culvert Interior
Slope	1.00%	
Structural Condition	7	
Channel	Information	
Stream Gradient	1.25%	
Bankfull width (ft)	4.25	
Prioritiza	tion Analysis	
Habitat Length (mi)	2.719	
Habitat Quality	6.1	
Barrier Severity	2	
Distance to ESH (mi)	3.846	
Distance to CH (mi)	3.846	A-14-1555
Habitat Length Points	4	
Habitat Quality Points	3	
Barrier Points	2	
ESH Points	0.131	Culvert Outlet
CH Points	0.131	
Barrier Type	Barrier	
Barrier Rank	4	
Total Points	9.262

Culve	rt Location	Culvert Key # 340015FDB1 Group 4
Road Name	Timmerman Rd	
Milepost	0.878	
Watershed	Gales Creek	
Stream Name	Trib to Little Beaver Creek	
Latitude	45° 37.156' N	As Contraction
Longitude	123° 13.054' W	CALL TO A
Culvert Key #	340015FDB1	
County Asset #	N/A	
Culvert	Information	
Shape	Circular	A REAL PROVIDENCE AND A
Material	Precast Concrete	prome U. off
Length (ft)	73	SC 10/10/08
Width (ft)	1.5	Inlet
Height (ft)	1.5	
Outlet Perch (ft)	1	Culvert Inlet
Slope	5.88%	
Structural Condition	N/A	
Channe	Information	
Stream Gradient	6.50%	
Bankfull width (ft)	4.875	
Prioritiza	tion Analysis	
Habitat Length (mi)	0.1	
Habitat Quality	7.4	
Barrier Severity	2	
Distance to ESH (mi)	1.96	
Distance to CH (mi)	1.96	Timeraco, SA
Habitat Length Points	1	SC 10/10/01
Habitat Quality Points	3	
Barrier Points	3	
ESH Points	0.557	Culvert Outlet
CH Points	0.557	
Barrier Type	Barrier	
Barrier Rank	12	
Total Points	8.115

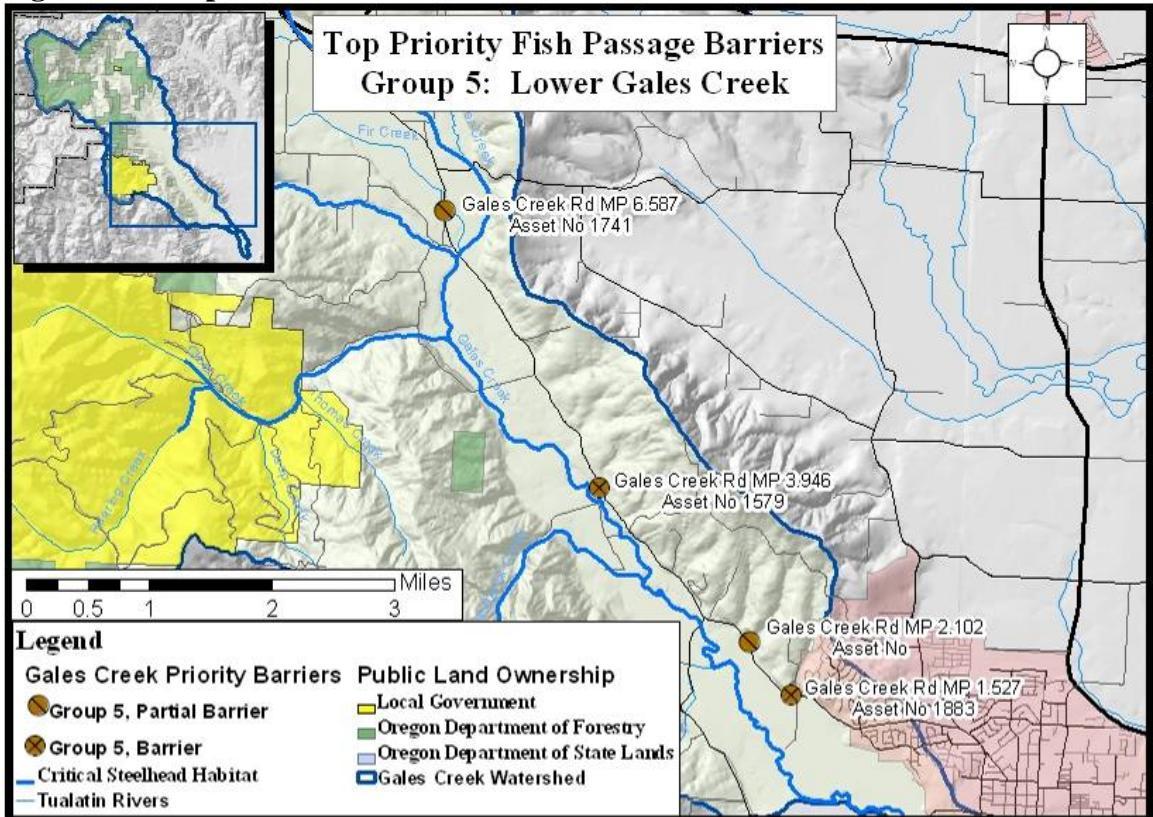
Culve	rt Location	Culvert Key # 340015FFC9 Group 5
Road Name	Gales Creek Rd	
Milepost	1.527	
Watershed	Gales Creek	
Stream Name	Trib to Gales Creek	
Latitude	45° 32.010' N	
Longitude	123° 09.241' W	
Culvert Key #	340015FFC9	
County Asset #	1883	A A A A A A A A A A A A A A A A A A A
Culvert	Information	
Shape	Circular	
Material	Precast Concrete	COMPANY REAL PROPERTY
Length (ft)	54	
Width (ft)	3	All the state
Height (ft)	3	
Outlet Perch (ft)	1.92	Culvert Outlet
Slope	1.87%	
Structural Condition	8	
Channe	I Information	
Stream Gradient	0.90%	A CONTRACTOR OF THE OWNER OWNER OF THE OWNER OWNE
Bankfull width (ft)	4.25	
Prioritiza	tion Analysis	
Habitat Length (mi)	1.025	
Habitat Quality	5.3	
Barrier Severity	2	
Distance to ESH (mi)	1.675	
Distance to CH (mi)	1.675	
Habitat Length Points	3	
Habitat Quality Points	3	
Barrier Points	2	
ESH Points	0.622	Culvert Interior Looking Upstream
CH Points	0.622	Private double culverts located upstream

Barrier Type	Barrier	of County barrier
Barrier Rank	5	
Total Points	9.243

Culver	rt Location	Culvert Key # 340015FFCD Group 5
Road Name	Gales Creek Rd	
Milepost	2.102	
Watershed	Gales Creek	
Stream Name	Trib to Gales Creek	
Latitude	45° 32.344' N	
Longitude	123° 09.654' W	
Culvert Key #	340015FFCD	
County Asset #	N/A	
Culvert	Information	
Shape	Circular	
Material	Precast Concrete	Galestreek Z.102
Length (ft)	49	sc Il/18/08
Width (ft)	2	Out A
Height (ft)	2	
Outlet Perch (ft)	0	Culvert Outlet
Slope	3.69%	
Structural Condition	8	
Channel	Information	
Stream Gradient	2.75%	(HIII)
Bankfull width (ft)	5.625	
Prioritiza	tion Analysis	
Habitat Length (mi)	0.679	
Habitat Quality	6.3	
Barrier Severity	2	
Distance to ESH (mi)	0.225	
Distance to CH (mi)	0.225	
Habitat Length Points	2	
Habitat Quality Points	3	
Barrier Points	2	
ESH Points	0.949	Culvert Interior
CH Points	0.949	
Barrier Type	Partial Barrier	
Barrier Rank	10	
Total Points	8.898

Culver	rt Location	Culvert Key # 340015FFF0 Group 5
Road Name	Gales Creek Rd	
Milepost	6.588	
Watershed	Gales Creek	
Stream Name	Fir Creek	
Latitude	45° 35.333' N	and the second se
Longitude	123° 12.904' W	ALA
Culvert Key #	340015FFF0	
County Asset #	1741	
Culvert	Information	
Shape	Pipe Arch	
Material	Corrugated Steel	the second second second second
Length (ft)	60	
Width (ft)	7	Gales Creek 6.588 Asset # 1741
Height (ft)	5	SC 11/17/08
Outlet Perch (ft)	0	Culvert Inlet
Slope	1.00%	
Structural Condition	8	
Channel	Information	
Stream Gradient	1.38%	
Bankfull width (ft)	7.25	
Prioritiza	tion Analysis	
Habitat Length (mi)	2.798	
Habitat Quality	5.9	
Barrier Severity	1	
Distance to ESH (mi)	0.446	
Distance to CH (mi)	0.446	
Habitat Length Points	4	
Habitat Quality Points	3	
Barrier Points	1	
ESH Points	0.899	Culvert Interior
CH Points	0.899	1
Barrier Type	Partial Barrier	1
Barrier Rank	11	
Total Points	8.799

Culver	t Location	Culvert Key # 340015FD05	Group 5
Road Name	Gales Creek Rd		
Milepost	3.946		
Watershed	Gales Creek		
Stream Name	Trib to Gales Creek		
Latitude	45° 33.417' N		VARIA PAR
Longitude	123° 11.236' W		
Culvert Key #	340015FD05		P
County Asset #	1579		t den
Culvert	Information		
Shape	Circular		
Material	Steel Bored		Contract of
Length (ft)	86	Gales Creek 3946	The second
Width (ft)	2.5	Outlet	A series
Height (ft)	2.5		
Outlet Perch (ft)	2.33	Culvert Outle	t
Slope	2.15%		
Structural Condition	8		
Channel	Information		
Stream Gradient	10.00%		A CONTRACTOR OF THE
Bankfull width (ft)	4.875		
Prioritiza	tion Analysis		
Habitat Length (mi)	0.1		
Habitat Quality	6.8		
Barrier Severity	2	and the second states	
Distance to ESH (mi)	0.032		
Distance to CH (mi)	0.032		Char
Habitat Length Points	1		
Habitat Quality Points	3		10% 日本市
Barrier Points	2		CARDA P. P. State
ESH Points	0.993	Culvert Interio	or 🛛
CH Points	0.993

Barrier Type	Barrier		
Barrier Rank	15		
Total Points	7.986

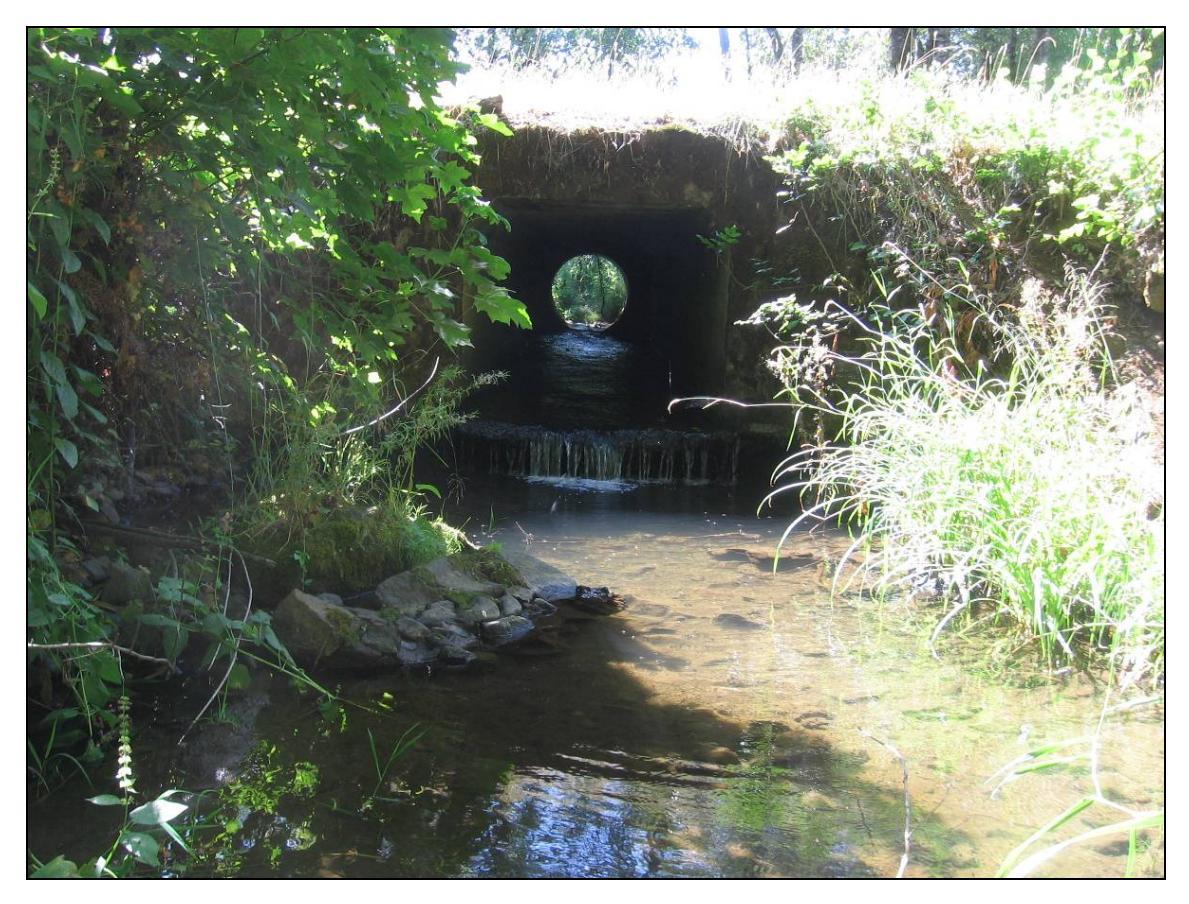
Gales Creek Road culvert on White Creek near the confluence with Gales Creek
