GALES CREEK LARGE WOODY DEBRIS INVENTORY REPORT

Tualatin River Watershed Council

ABR, Inc.—Environmental Research and Services

February 27, 2006

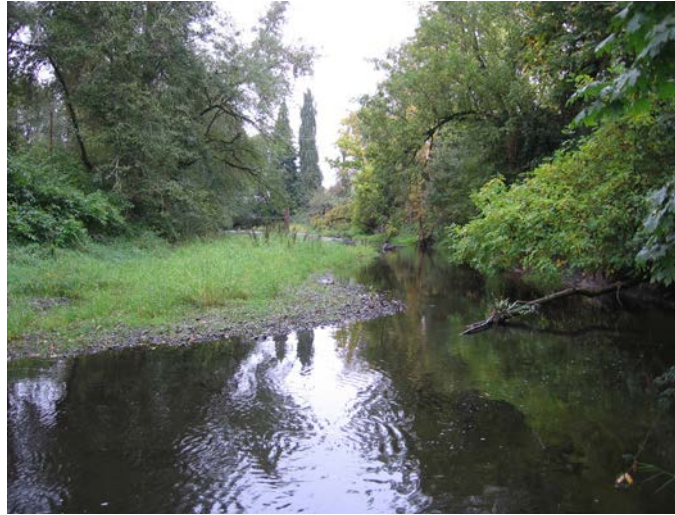
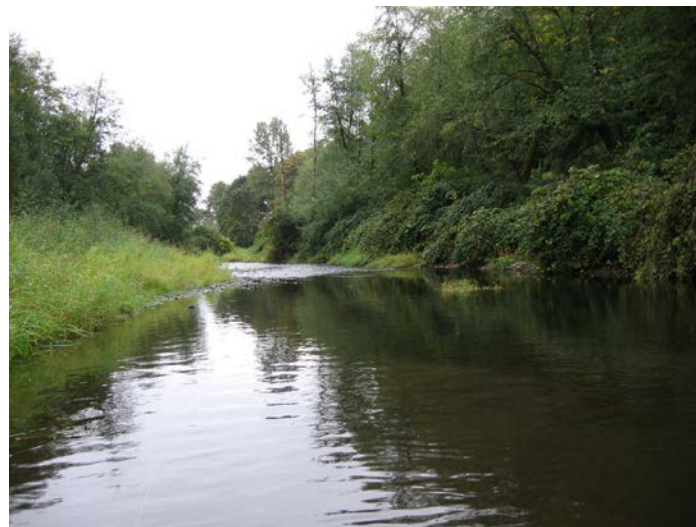
Reach GL02 begins at the confluence of Gales and Kelly Creeks and extends upstream approximately 3,100 ft (Figure 2). Habitat types in GL02 include riffles, glides and pools with a mean gradient of 1% (Figure 3).

The air temperature and water temperature at GL02 were 8 °C and 10 °C, respectively. On average, GL02 had 16.0 pieces LWD per 200-ft reach. A total of 80 pieces of qualifying wood were observed within the survey, with one piece observed within the stream. The remaining 79 pieces were observed within the recruitment zone of the creek. Within the recruitment zone, 11 pieces were dead or perched for recruitment while 68 were live trees (Table 2). The majority (87.5%) of the LWD surveyed within the reach fell within the 1-2 ft diameter class (Table 3). No large debris jams or notable wood features were observed within the surveyed reach segments on GL02.

Figure 3. Photos of GL02 facing into the start of the reach (upper) and the end of the reach (lower). These photos show pool, glide and riffle habitats encountered within the reach GL02.

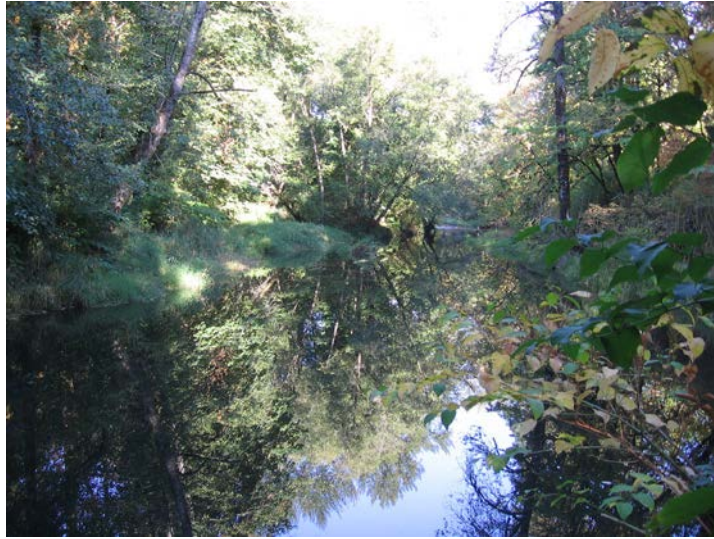
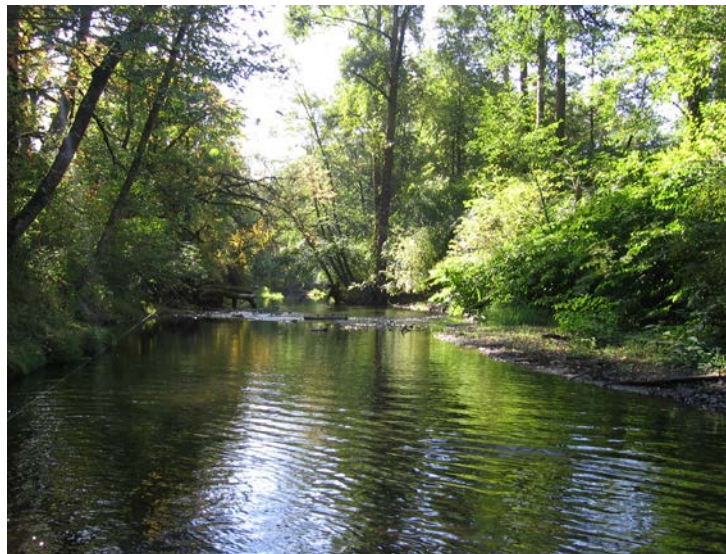
Reach GL05 begins where Roderick Road crosses Gales Creek and extends upstream approximately 1000 ft (Figure 4). Habitat types within GL05 include riffles, glides and pools with a mean gradient of 2% (Figure 5).

The air temperature and water temperature in GL05 were 9 °C and 11 °C, respectively. On average, GL05 had 25.4 pieces LWD per 200-ft reach. One hundred twenty-seven pieces of qualifying wood were observed within the survey area, with 13 pieces observed within the bankfull width of the Gales Creek. The remaining 114 pieces were observed within the recruitment zone. Of these pieces for potential introduction, eight were dead or perched for recruitment; 106 were live trees (Table 2). The majority (89.8%) of the LWD surveyed within the reach fell into the 1-2 ft diameter class (Table 3). Two large debris jams were observed within the survey segments (Figures 4 and 6). The jams contained five and four pieces of qualifying wood and distinguished no habitat changes (Table 4).

Figure 5. Photos of GL05 facing into the start of the reach (upper) and the end of the reach (lower). These photos show pool, glide and riffle habitats encountered within the reach.

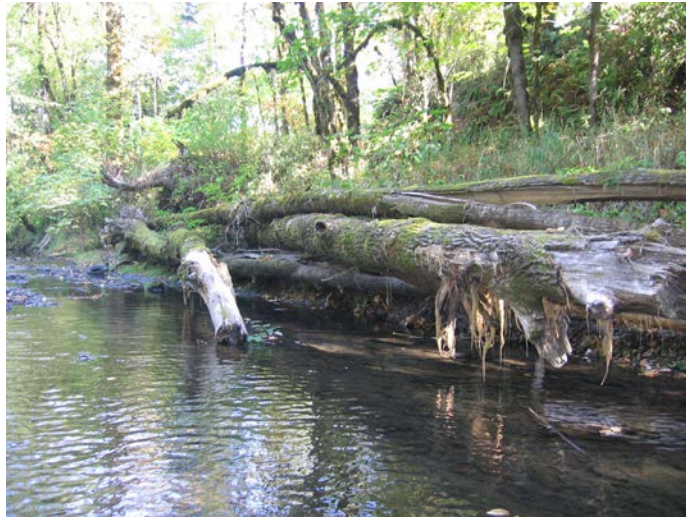
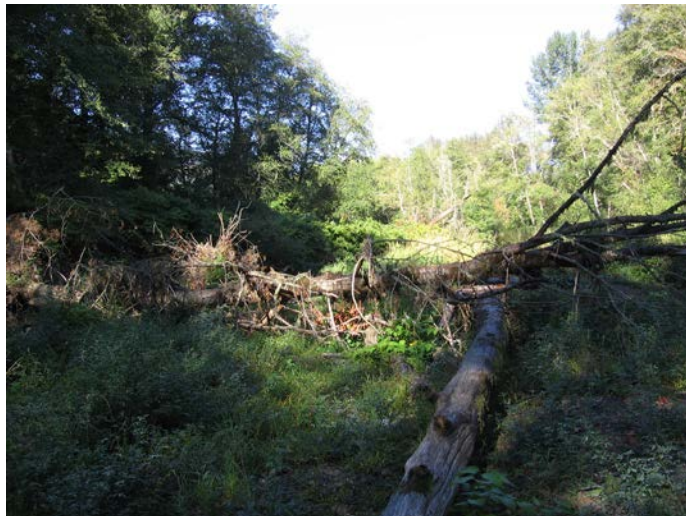
Figure 6. Debris jams in GL05: left bank (upper photo) and gravel bar, mid-channel (lower photo).

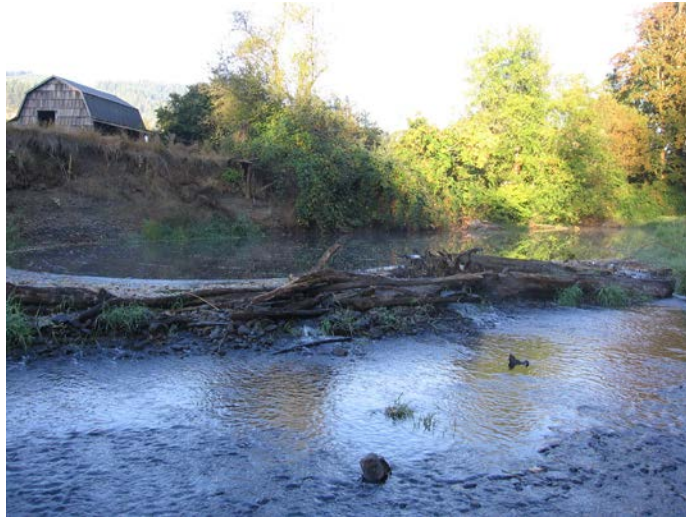
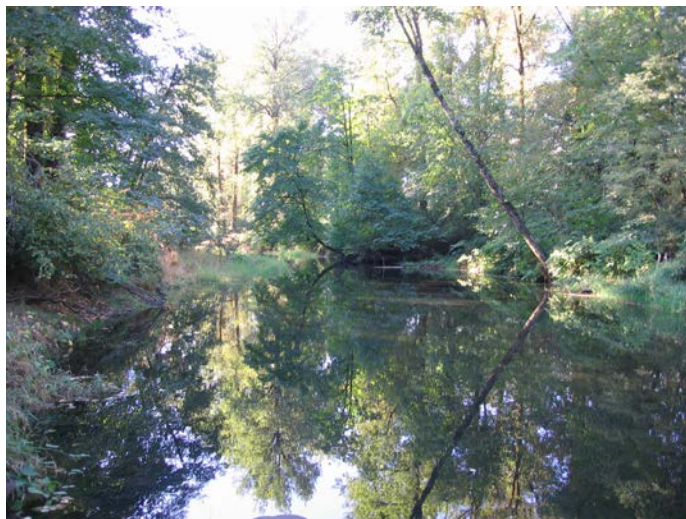
Reach GL06 begins 900 ft downstream of the Roderick Road crossing of Gales Creek and extends upstream, ending at this crossing (Figure 4). Habitat types encountered included glides and pools with a mean gradient of 1% (Figure 7).

Figure 7. Photos of GL06 facing into the start of the reach (upper) and the end of the reach (lower). These photos show glide and pool habitats encountered within the reach.

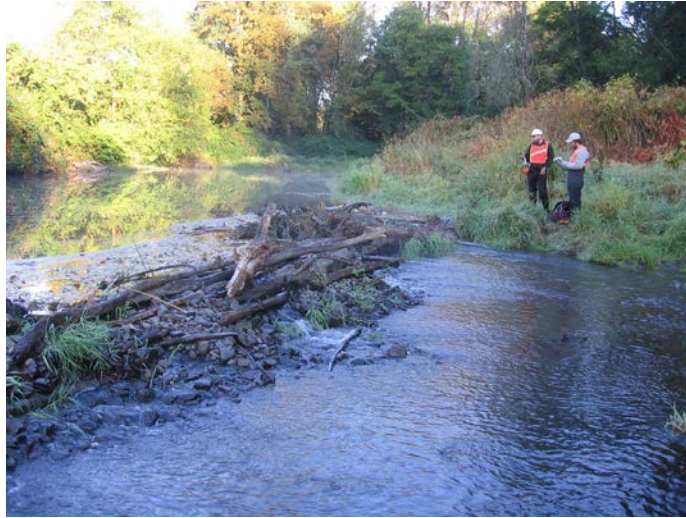
The air temperature and water temperature were 5.5 °C and 11 °C, respectively. On average, GL06 had 16.0 pieces LWD per 200-ft reach. A total of 72 pieces of qualifying wood were observed during the survey, with five pieces observed within bankfull width of the stream. The remaining 67 pieces were observed within the recruitment zone outside of either bankfull of the creek. Of these pieces for potential introduction, nine were dead or perched for recruitment while the remaining 58 were live trees (Table 2). The majority (59.7%) of the LWD surveyed within the reach sized within the 1-2 ft diameter class (Table 3). One large debris jam was observed within the survey segments (Figures 4 and 8). This debris jam contained three pieces of qualifying wood and marked a change in habitat type from pool above the jam to riffle below (Table 4).

Figure 8. Photo of the large debris jam, spanning the wetted channel, in GL06.

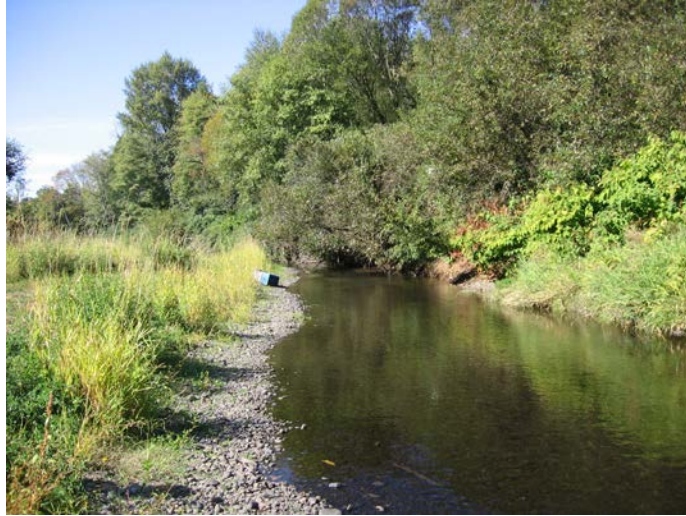
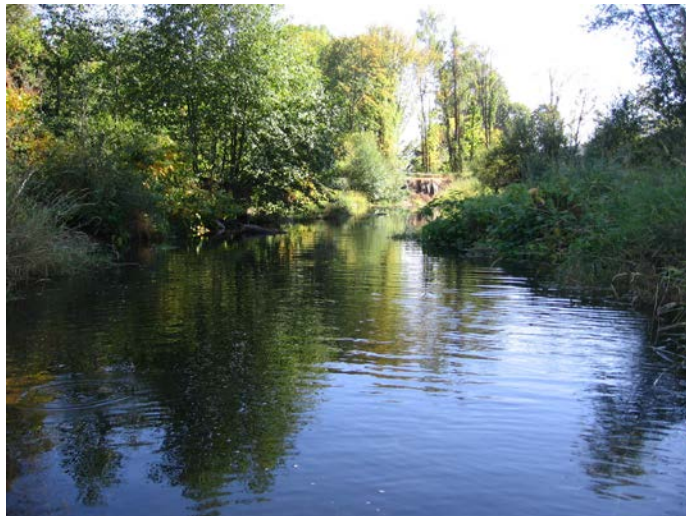
Reach GL08 begins approximately 2,500 ft above the Springtown Road crossing and extends upstream 1,600 ft (Figure 9). Habitat types in GL08 include riffles, glides and pools with a mean gradient of 1% (Figure 10).

Figure 10. Photos of reach GL08 facing into the start of the reach (upper) and the end of the reach (lower). These photos reveal glide and pool habitats encountered within the reach; riffle habitats were also observed in GL08.

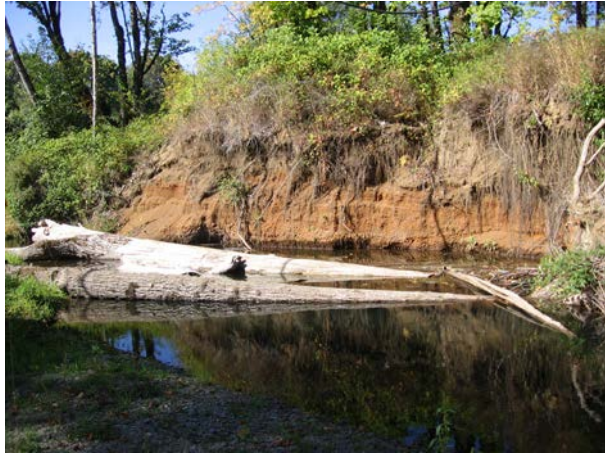
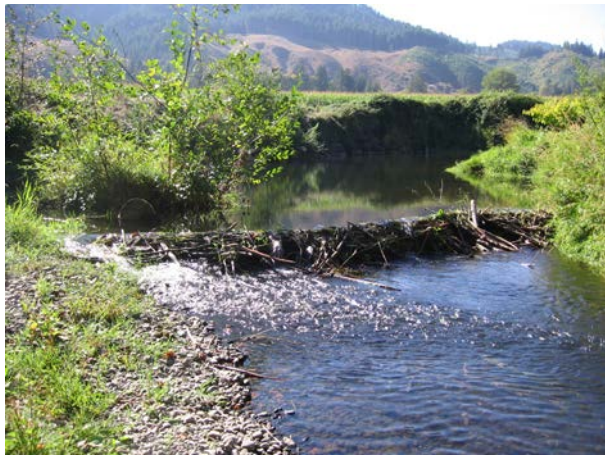
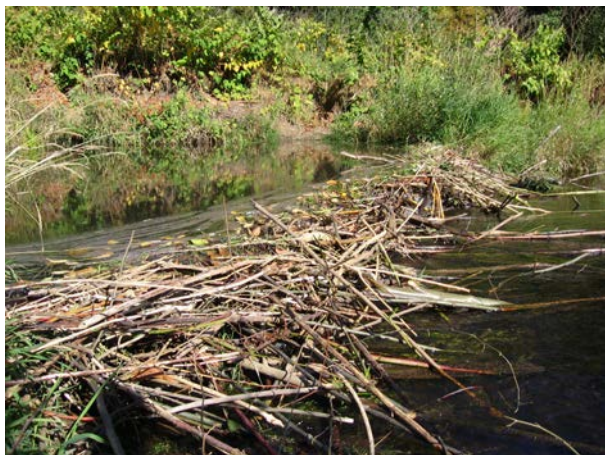
The air temperature and water temperature were 18 °C and 15 °C, respectively. On average, GL08 had 12.4 pieces LWD per 200-ft reach. Sixty-two pieces of qualifying wood were observed within the survey; four of these pieces were lying within the stream's bankfull width. The remaining 58 pieces were observed within the recruitment zone on either bank. Within the recruitment zone, twelve pieces of LWD were dead or perched for recruitment. Forty-six trees were live (Table 2). The majority (85.5%) of the LWD surveyed within the reach sized within the 1-2 ft diameter class (Table 3). One large debris jam, containing four pieces of qualifying wood, and two beaver dams were observed within the survey segments (Figures 9 and 11). The beaver dams contained no qualifying wood pieces, but marked changes from pool to riffle habitat types (Figure 11).

Figure 11. Debris jam, located mid-channel, within a pool (upper photo) and two beaver dams (middle and lower photos), spanning the wetted channel in GL08.

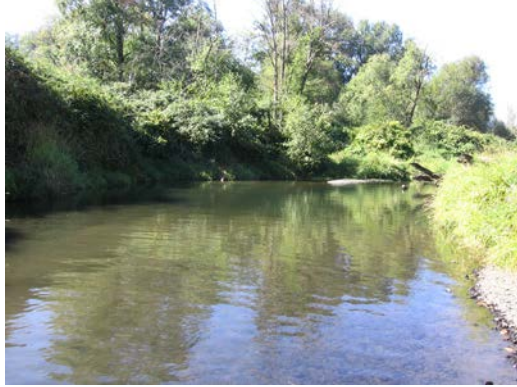
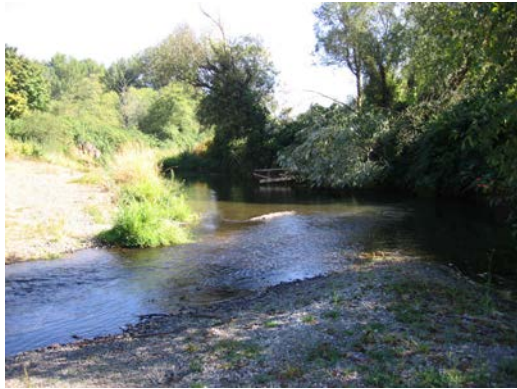
Reach GL09 begins approximately 930 ft above the Springtown Road crossing of Gales Creek and extends upstream 1,700 ft (Figure 9). Habitat types in GL09 include riffles, glides and pools with a mean gradient of 1% (Figure 12).

Figure 12. Photos of reach GL09 into the start of the reach (upper) and the end of the reach (lower). These photos show pool, glide and riffle habitats encountered within the reach.

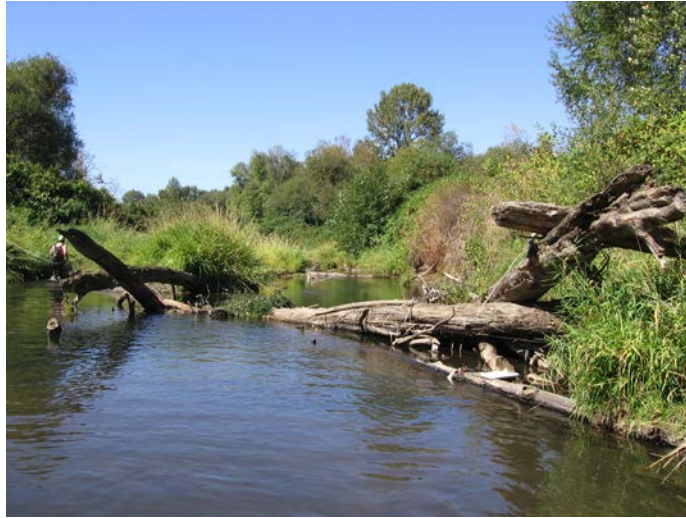
On the survey date, the air temperature and water temperature at GL09 were 18 °C and 15 °C, respectively. On average, GL09 had 9.8 pieces LWD per 200 ft reach. Of the fifty-four pieces of qualifying wood observed within GL09, 11 pieces were within the stream's bankfull width. The remaining 43 pieces were observed within the recruitment zone on either side of the creek. Six pieces within the recruitment zone were dead or perched for recruitment, while 37 pieces were live (Table 2). The majority (83.3%) of the LWD surveyed within the reach sized within the 1-2 ft diameter class (Table 3). One large debris jam was observed within the survey segments (Figures 9 and 13). This jam contained five pieces of qualifying wood, and marked no change in habitat type (Table 4).

Figure 13. Large debris jam on left bank in reach GL09.
