Reach RL01

Existing Conditions

Reach RL02

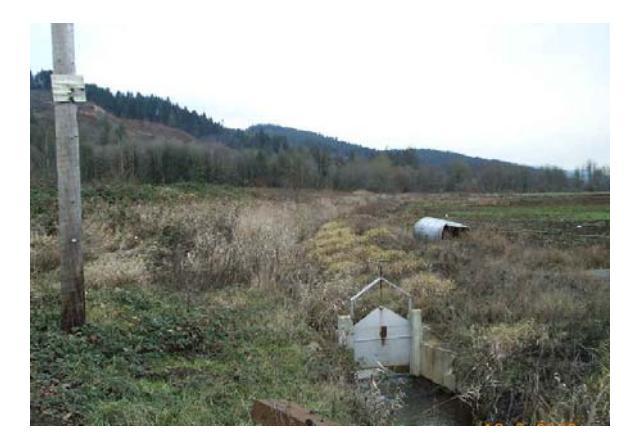
- Water Quantity: There is one permitted irrigation diversion from this reach. There is a sluice gate across the creek near the end of the local access road. It is not clear whether the sluice gate is located at the permitted diversion point or if it is an illegal diversion. It appears that this gate may be used to back up water in the creek for irrigation withdrawal purposes (perhaps flood irrigation). If the gate is in a closed, or partially open position, it appears that it would cause a passage barrier. Table 4-10 presents OWRD permitted diversion information for the reach.

- *Habitat Access:* An irrigation diversion gate located approximately 20 feet upstream of the local access road appears to form an effective passage barrier. The culvert under the local access road (approximately 40 feet long) may also be a barrier. The downstream invert of the culvert is about a foot higher than the invert of the stream.
- Habitat Elements: No formal habitat survey was completed for Roderick Creek. However, in 1999, ODFW identified Roderick Creek as having adequate steelhead habitat from its confluence with Gales Creek, up to the headwaters of the creek. The reach has mainly a sediment bed with some exposed gravels and cobbles at riffles. It appears to have glide characteristics throughout most of the reach. The LWD volume is very low.

Photo RL02-1 Looking upstream (northwest) along Roderick Creek. A small shuice gate structure on the lower section of the creek may be a passage barrier. The reach lacks a sufficient cover of trees and shrubs to shade the channel.

Work with OWRD to evaluate the status of this diversion. Work with ODFW to ascertain if there truly is steelhead habitat upstream of the culvert that runs under the road and upstream of the sluice gate in the channel.

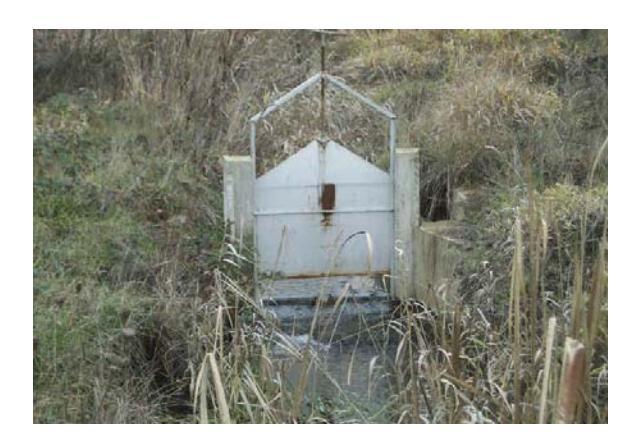
Photo RL02-2 A close-up photo of small slice gate structure on Roderick Creek. The photo was taken in late autumn of 2002.

If there is valuable fish habitat upstream of the culvert and the sluice gate and they are determined to be barriers to passage, work with the landowner to mitigate the effects.
