SMALL GRANT PROGRAM

PROJECT COMPLETION REPORT

Name of Project **Bateman Creek Culvert Replacement Project**

Project Number: **13-06-009**

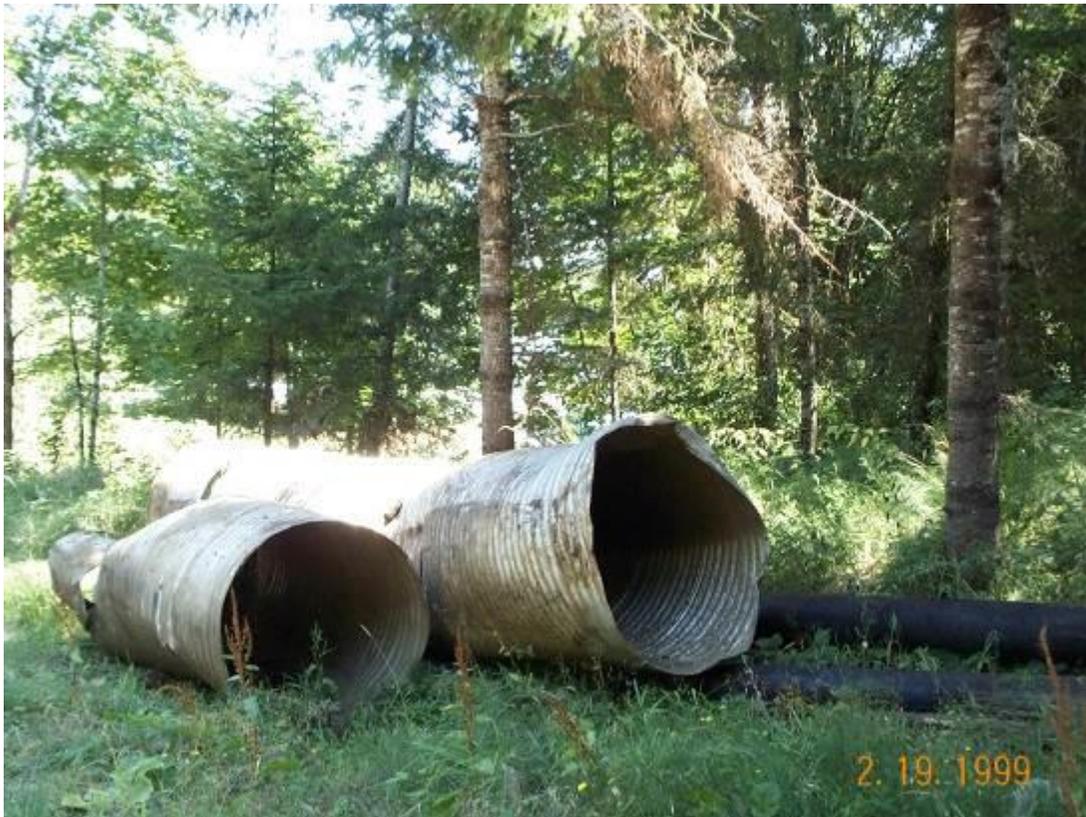
Picture 1: Culverts removed from the streambed.

The work began in August 2006 and was completed in late September 2006. It included removing two culverts, (36 inches in diameter, one of which was crushed and other which was rusting), constructing footings for and installing three 21' by 4' by 1' concrete slabs (weighing 12,000 pounds each) onto the footings and bolting the bridge together. The estimated weigh the bridge will support is 80,000 pounds on five axles, which will be sufficient for future logging activities.

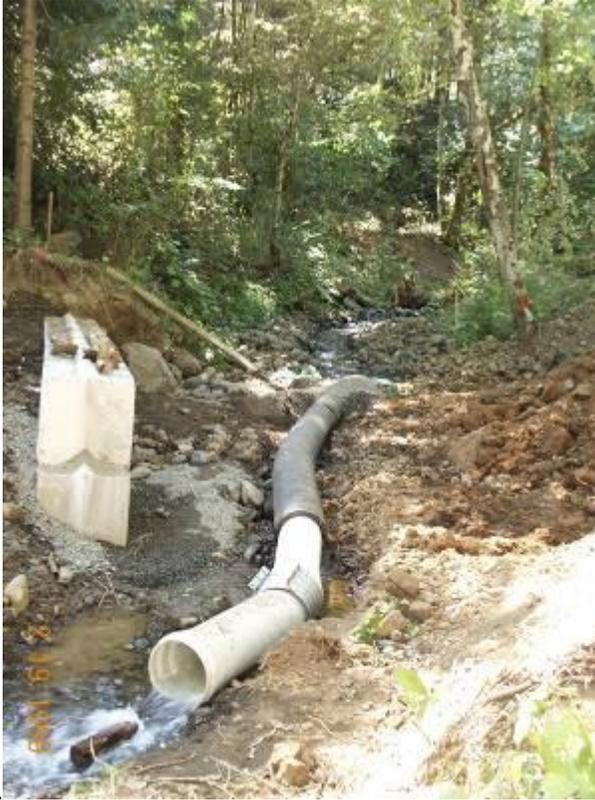
Picture 2: The stream is re-routed in a temporary culvert through the work areas following culvert removal. Building the footings for the bridge (three layers of ecology blocks) has begun.

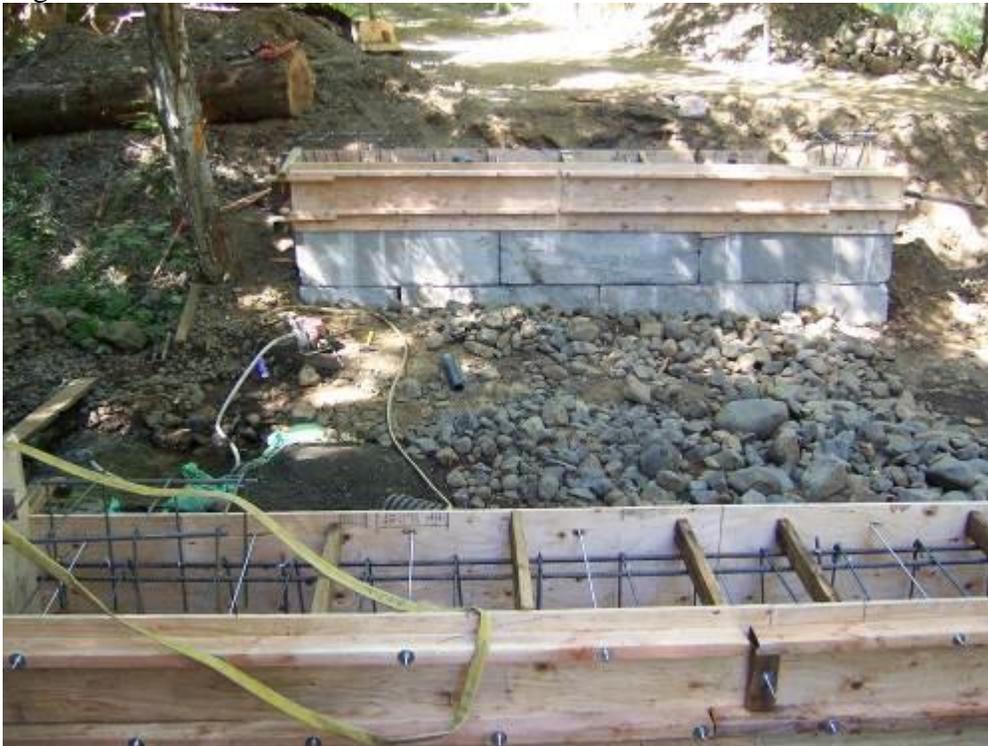
Picture 3: The completed forms await the cement delivery, mixing and pouring.

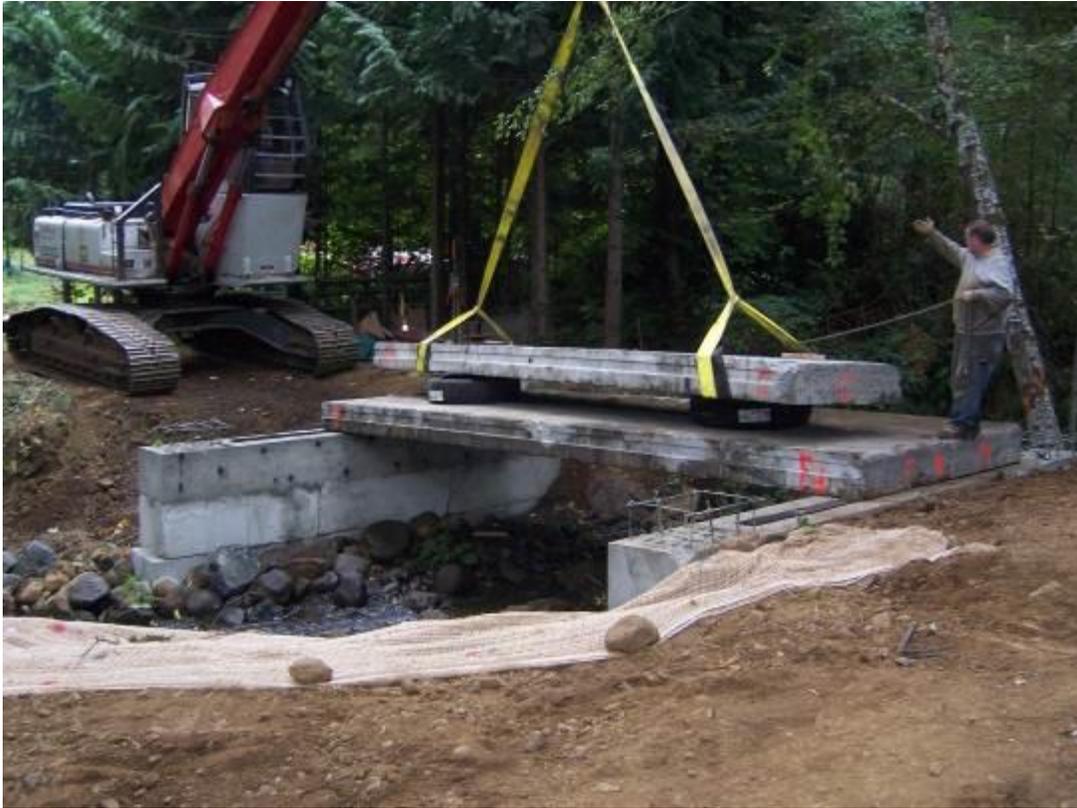
Picture 4: Putting the third and last bridge slab in place.

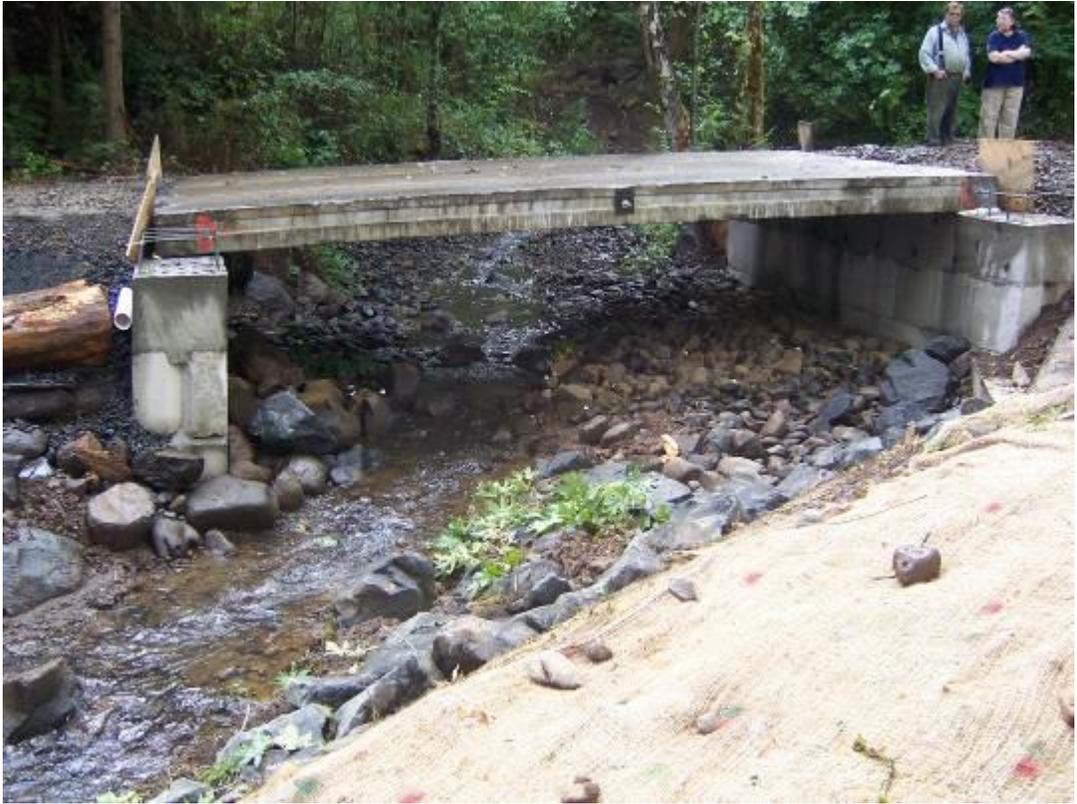
Picture 5: The completed bridge with the anchor bolt in place.

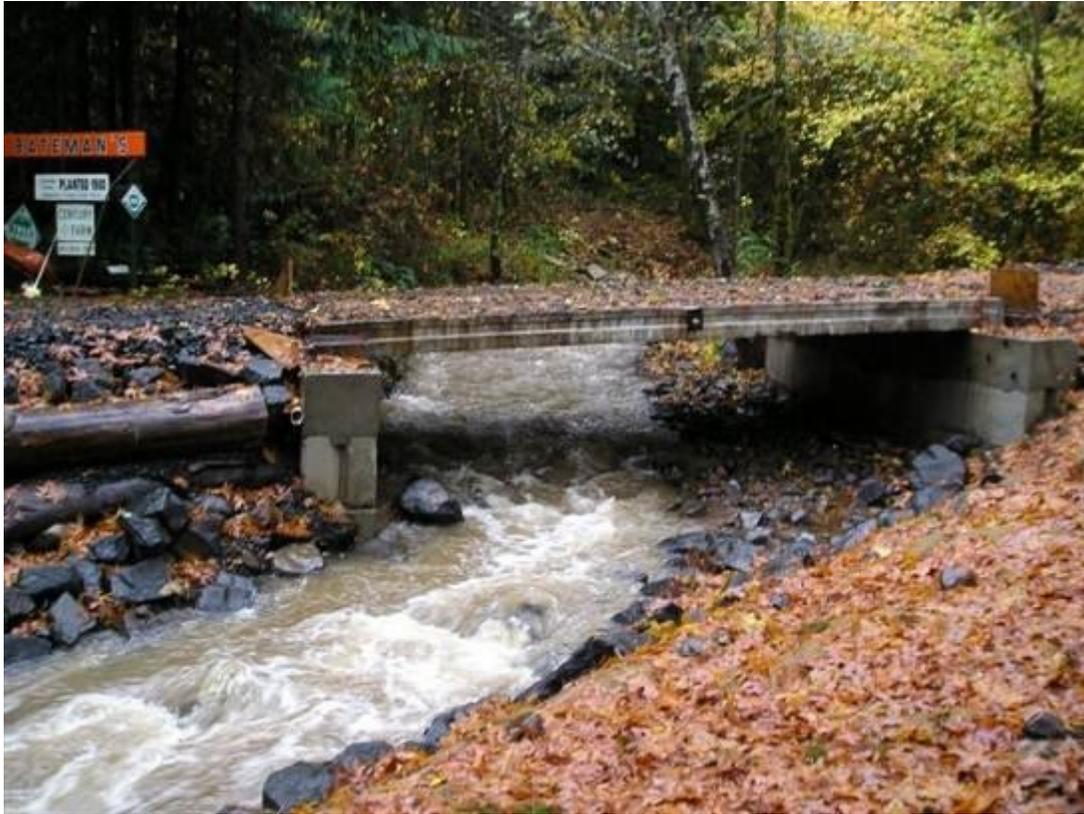
Picture 6: November 2006 flows under the completed bridge.

Results from installation of the bridge include unblocked passage for native cutthroat trout and winter steelhead trout; and better water quality and less sedimentation in the stream since there will be no debris blockages of culverts due to high winter flows. This bridge installation project was completed within several days of the adjacent Highway 6 Oregon
