TECHNICAL REPORT • DECEMBER 2019

# Hydrology Monitoring and Analysis for the Gales/Clear Creek Confluence Project: Synthesis of Pre-Enhancement and Post-Enhancement Conditions

PREPARED FOR  
Clean Water Services  
2550 Southwest Hillsboro Highway  
Hillsboro, Oregon 97123

PREPARED BY  
Stillwater Sciences  
108 NW Ninth Ave, Suite 200  
Portland, OR 97209

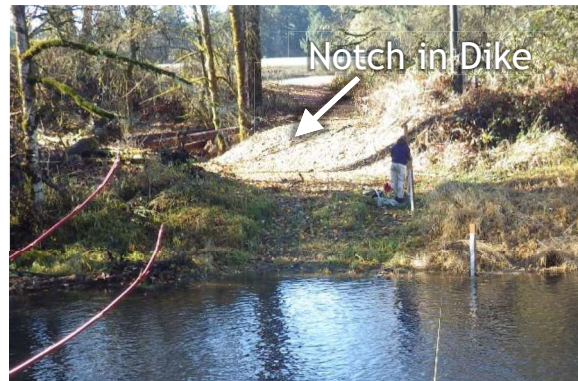
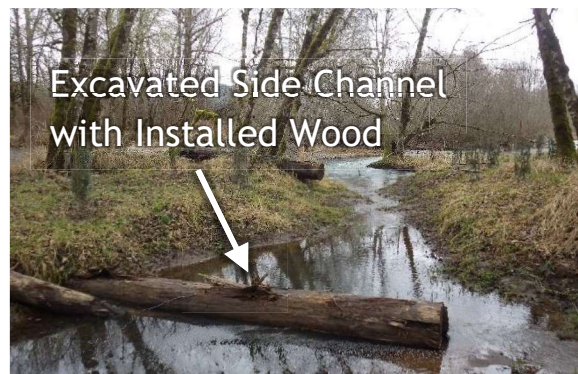
Views of the notched dike (top) and excavated side channels with installed large woody materials (bottom) constructed in summer 2018 (photos by Stillwater Sciences)

Construction of the habitat enhancements occurred between July 20, 2018 and August 5, 2018, which included notching the upstream dike, excavating the side channels, and installing large woody materials in the side channels and along Gales Creek (see photos at right). Planting of native trees throughout the site occurred in January 2019.

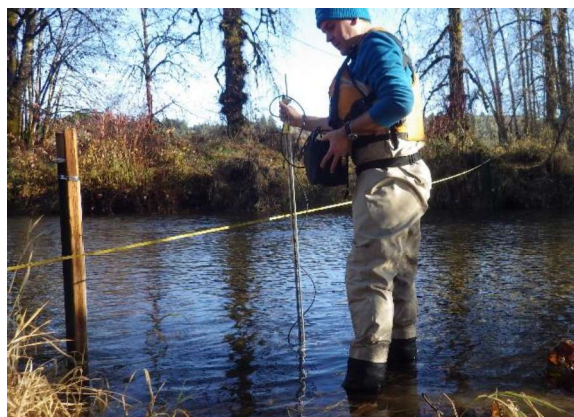
View of discharge measurement at S-1 on Gales Creek on December 3, 2018 (photo by Stillwater Sciences)

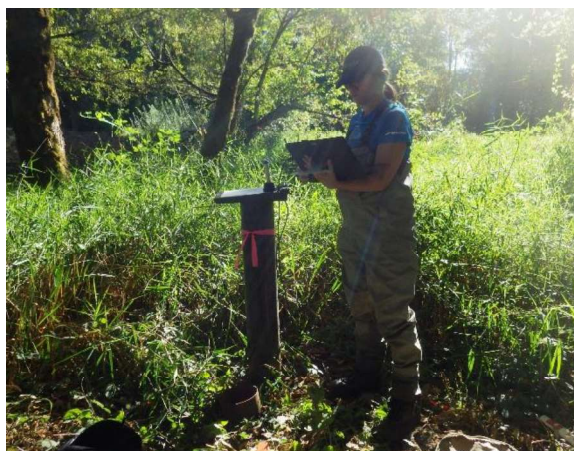
View of groundwater-level measurement and logger download at P-7 near the confluence of Gales and Clear creeks on September 26, 2018 (photo by Stillwater Sciences)

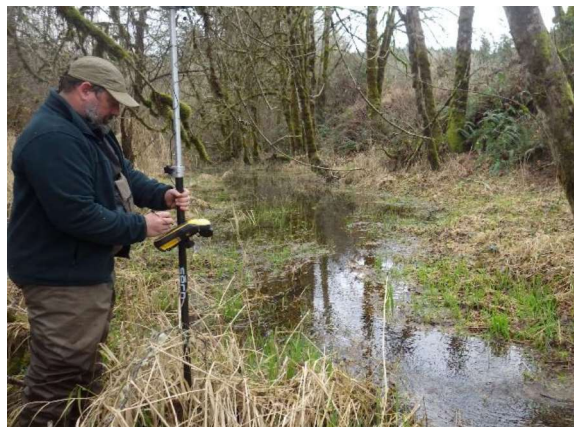
View of floodplain-inundation mapping near the southwest side of the Project site on January 24, 2019 (photo by Stillwater Sciences)

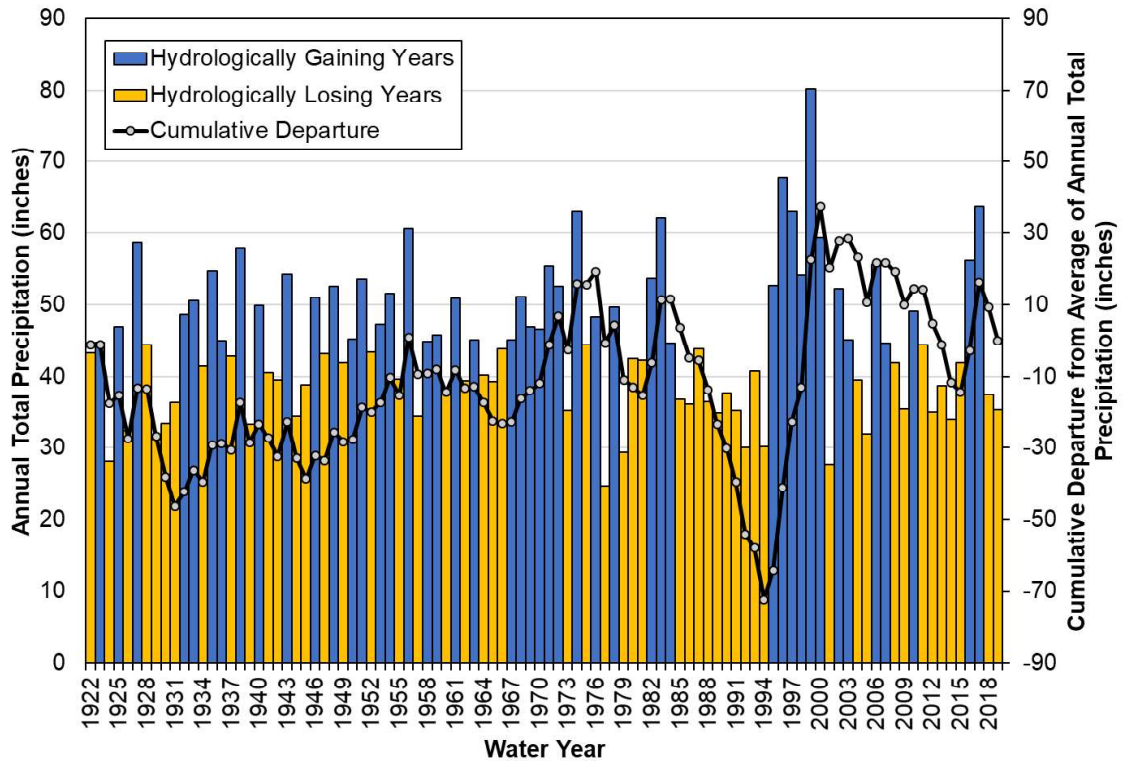
**Figure 4.** Long-term annual precipitation amount and patterns of variation from cumulative departure from average of annual total precipitation amounts near Forest Grove (source: NOAA NCDC; analysis: Stillwater Sciences).

An evaluation of longer-term precipitation trends since the 1920s reveals substantial annual variability, ranging over a factor of two. Longer-term cyclic patterns of precipitation can be visualized when plotting the cumulative departure, or difference, of each annual total from the long-term average of annual totals from water years 1922–2018 (Figure 4). The time-series of cumulative departures (black line in Figure 4) reveals decadal-scale patterns of generally wetter than average (i.e., gaining trend) and drier than average (i.e., losing trend) in the site vicinity. More recently, local rainfall received during water years 2018 and 2019 has been below the long-term average. These trends agree with regional records published by NOAA (2019b), where precipitation totals for water years 2018–2019 in the Tualatin River basin (and its neighboring

Coast Range and lower Willamette Valley basins) received approximately 70–90% of the long-term average during water years 1981–2010. Since monitoring initiated at the Project site in June 2017, discrete rainfall events recorded near Forest Grove having daily totals greater than 1 inch occurred ten times (Table 5).

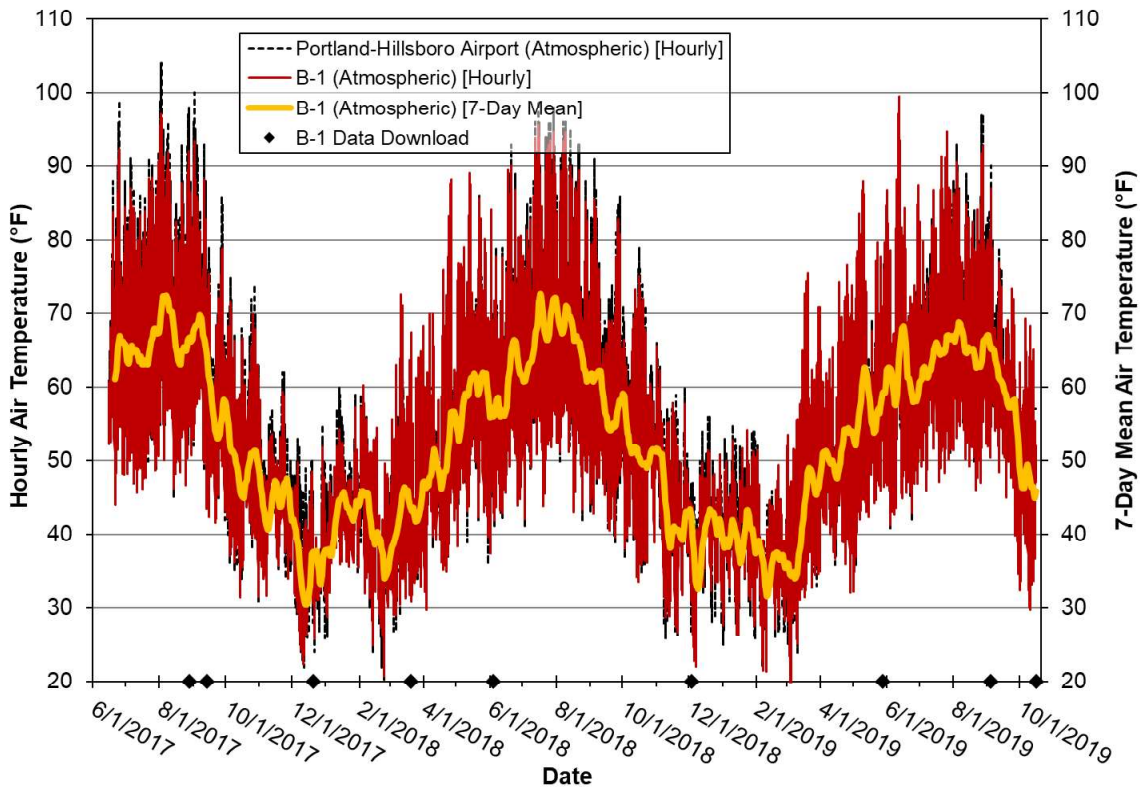
**Figure 5.** Hourly air temperatures measured at the Project site (B-1) and offsite (Portland-Hillsboro Airport), and the 7-day mean air temperatures at the Project site.

Air temperatures recorded hourly at the atmospheric sensor, B-1, installed at the Project site have tracked the seasonal and diurnal variations (Figure 5), which coincide with temperatures measured hourly at the Portland-Hillsboro Airport monitoring station. In the warmer summer months when elevated water temperatures can potentially limit fish habitat, the warmest daily mean air temperatures in water years 2017 and 2018 occurred on August 2, 2017 (78.1°F at B-1, 83.7°F at Hillsboro Airport) and July 12, 2018 (75.9°F at B-1, 79.4°F at Hillsboro Airport), respectively. For water year 2019, air temperatures were generally cooler; the warmest daily mean air temperature occurred on June 12, 2019 (75.0°F at B-1, 79.0°F at Hillsboro Airport).

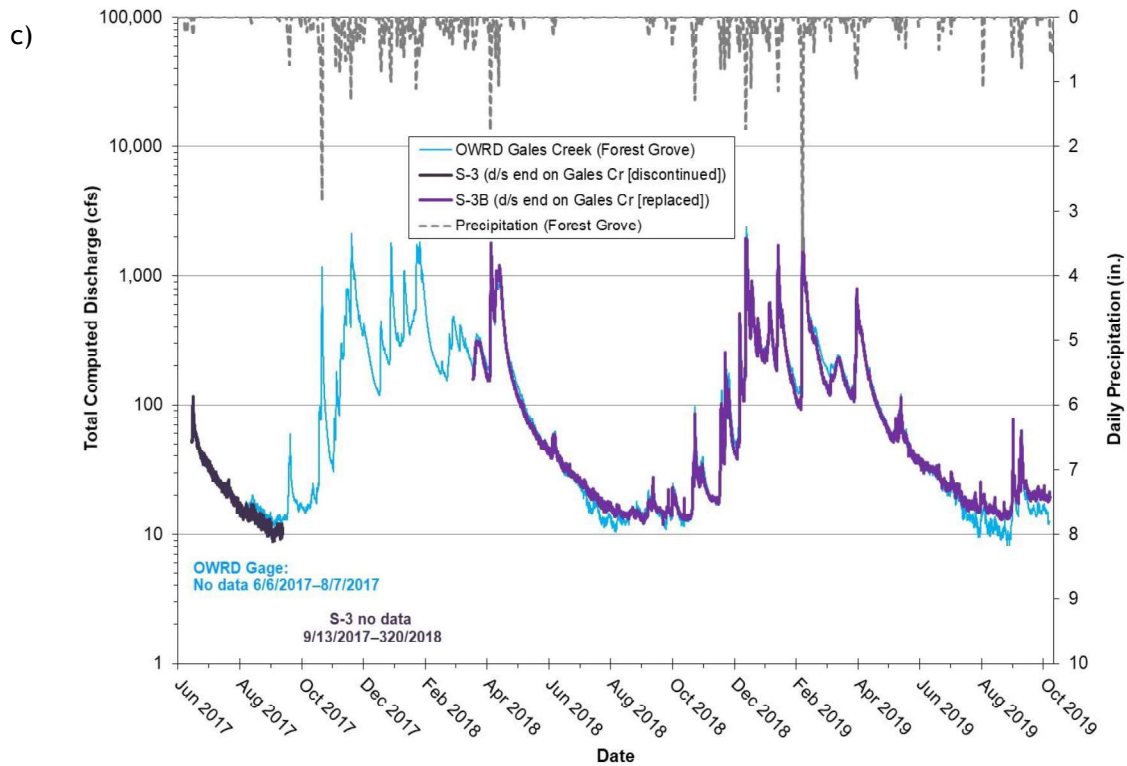
**Figure 7.** Computed discharge at streamflow gages installed in Gales and Clear creeks (a-c). Discharge reported at the OWRD Gales Creek stream gage and offsite precipitation measurements in the Project vicinity are shown for reference.

The magnitudes of discharge at each of the three onsite gages differ, with the smaller discharge contribution from Clear Creek adding to discharge in Gales Creek that generally exhibits increasing amounts with downstream-distance, a process called “accretion.” A strong curvilinear correlation ( $R^2 \approx 0.99$ ) exists between the Project site inflows (S-1 plus S-2) and outflows (S-3) under 1,000 cfs (Figure 8). The lower flows of this relationship (i.e., <100 cfs) in drier months have a linear 1:1 correlation indicating a relative balance between inflows and outflows, while the higher flows (i.e., 100–1,000 cfs) in wetter months have a steeper linear correlation indicating an increasing trend of accretion.

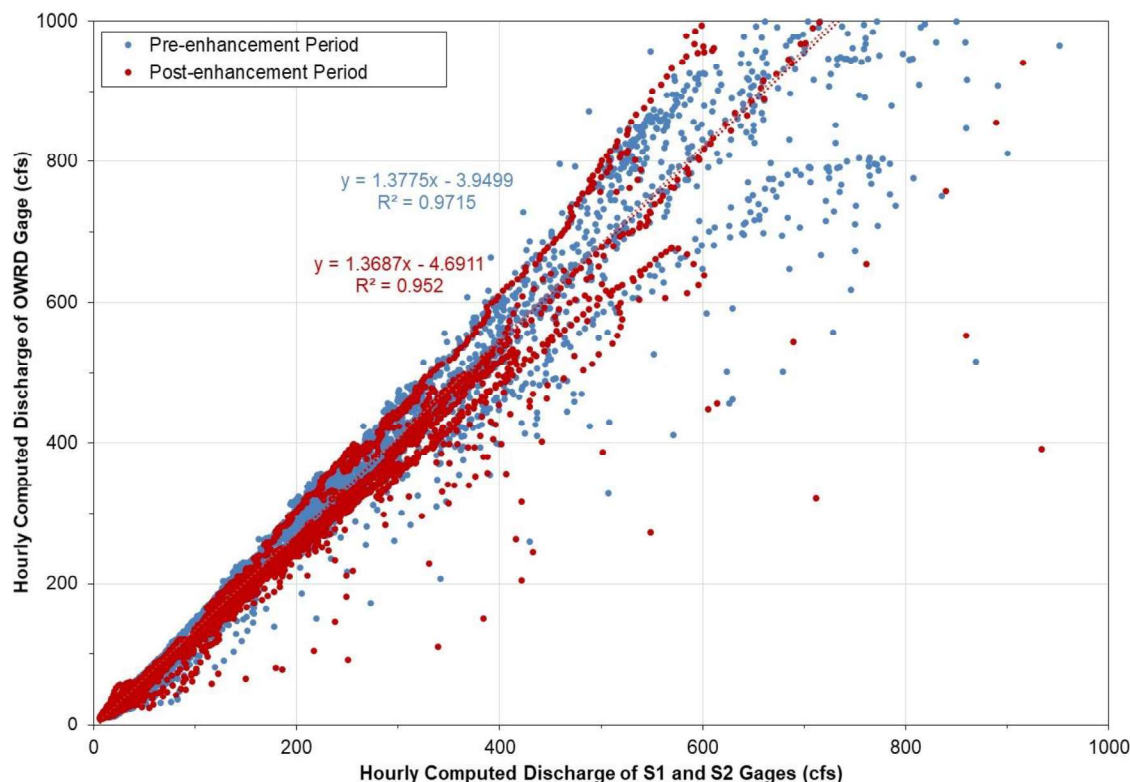
**Figure 8.** Regression of site inflows versus outflows at hourly time-steps during the monitoring period, showing overlap of the pre-enhancement and post-enhancement values.

Per the monitoring plan, evaluating changes in flow conveyance through the Project area in response to the constructed enhancement features can be achieved through observing any discrete shifts in proportional relationships between the site inflows (gages S-1 and S-2) and outflows (gages S-3 or OWRD at Forest Grove) over time. Figure 8 displays a regression plot of the total inflows (summation of S-1 and S-2 discharges) versus outflows (OWRD-gage discharge) at each hourly time-step of the monitoring period. The OWRD gage data are used here to overcome the data-gap in the S-3 gage records during fall 2017 and winter 2018. The discharge values from the two time periods—pre-enhancement and post-enhancement—are indistinct from one another, thus signifying that the streamflow monitoring activities have not observed any shift between the site inflows and outflows within the flow range of ~1–1,000 cfs since enhancement construction.

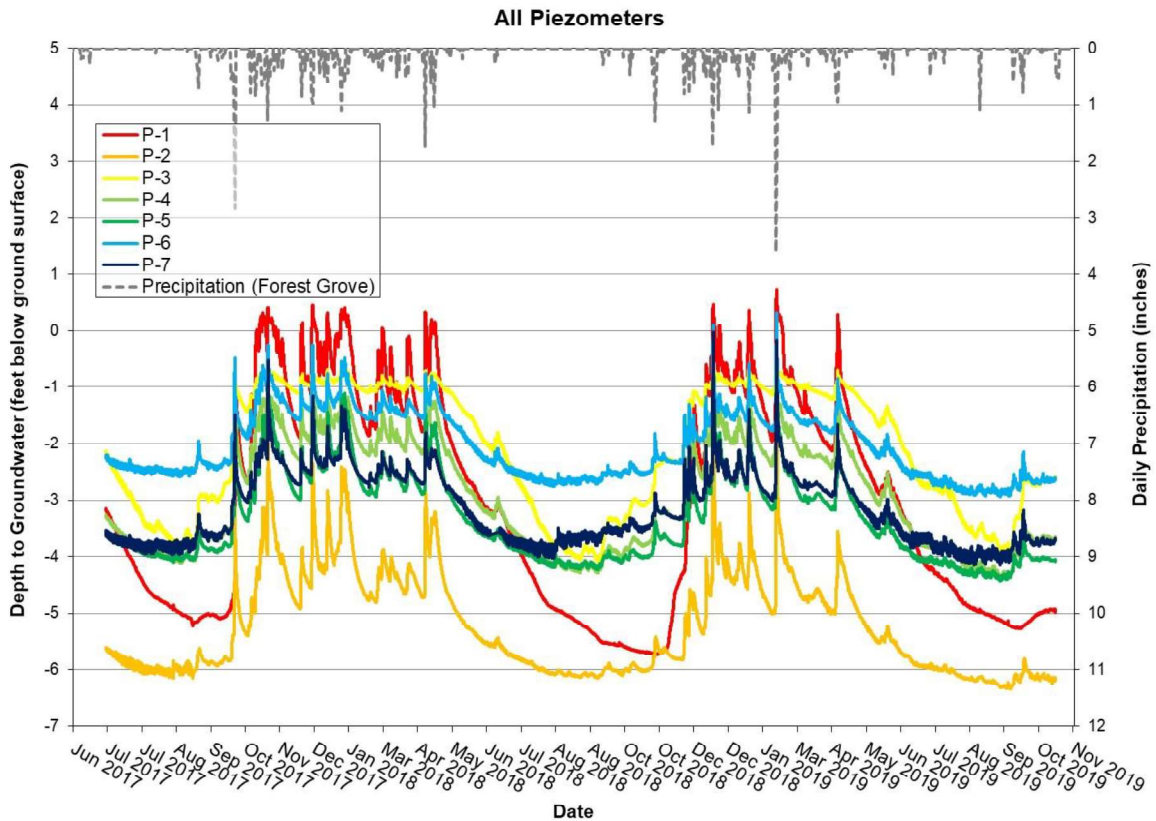
**Figure 9.** Groundwater levels measured in groundwater monitoring wells at the Project site. Offsite precipitation measurements in the Project vicinity are shown for reference.

The groundwater levels exhibited direct and rapid response to rainfall infiltration and surface-water runoff, marked by longer periods of deeper depths during summer months and shallower depths during winter months. Groundwater levels fluctuated between 3.3 and 6.5 feet, with the greatest range observed in well P-1, which is located near the low-lying meadow in the northwest portion of the site. The water table was observed rising above the ground surface at P-1 during multiple winter storm events in water years 2018–2019 and at P-6 (near Clear Creek) during two storm events in water year 2019: December 18, 2018 and February 12, 2019. Inundation mapping during January 2018 and 2019 confirmed inundation at or very close to these locations (see details below). Higher groundwater levels at P-1 were the steadiest and longest lasting during the wet seasons, as compared to the trends observed in the other wells, which were more closely linked to fluctuations in rainfall and streamflow.

All groundwater-level data exhibited a very slight, albeit statistically weak ( $R^2 < 10\%$ ), declining trend over the course of the monitoring period, which is attributable to the below-normal rainfall totals received in water years 2018–2019 following an above-normal rainfall total received in water year 2017. There are no indications of water-table changes since construction of the enhancement features.

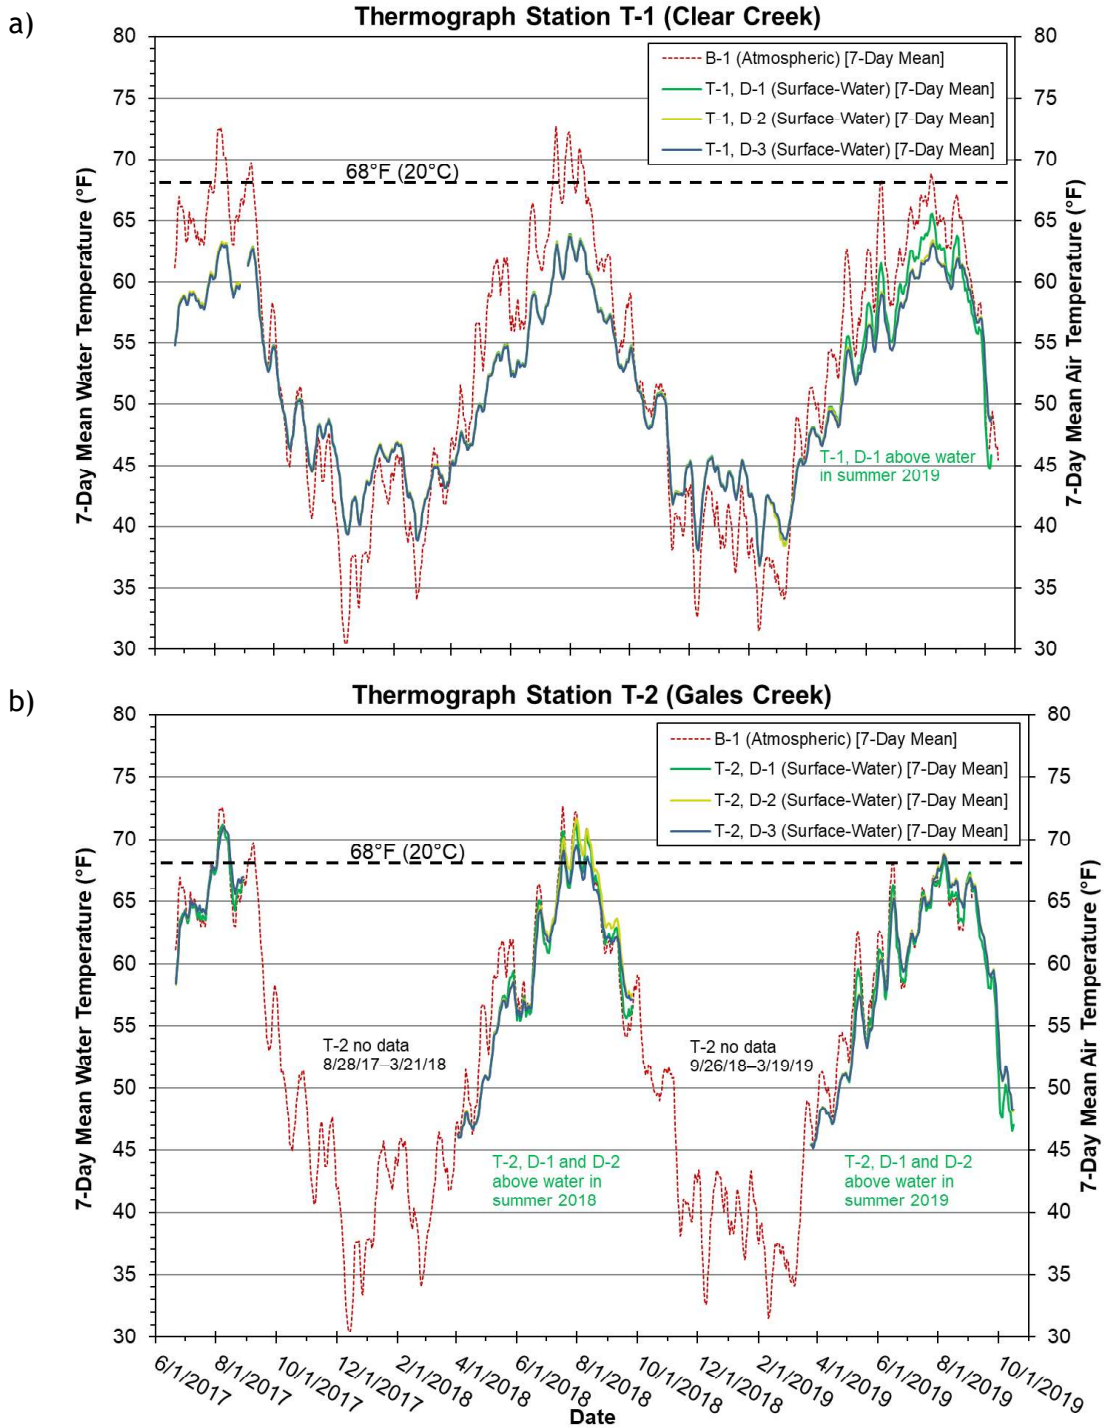
Figure 11. Seven-day average water temperature recorded in lower Clear Creek (a) and Gales Creek near the confluence (b). Onsite air-temperatures recorded at B-1 are shown for reference.

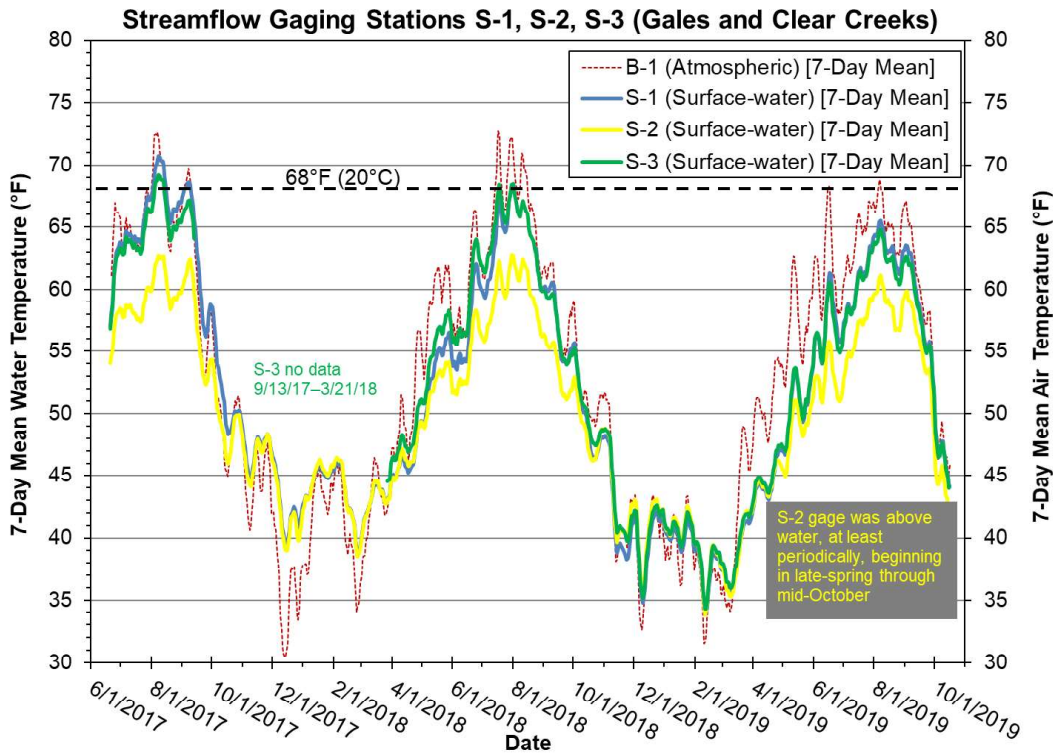
**Figure 12.** Seven-day average water temperatures recorded at the streamflow gages. Onsite air temperatures recorded at B-1 are shown for reference.

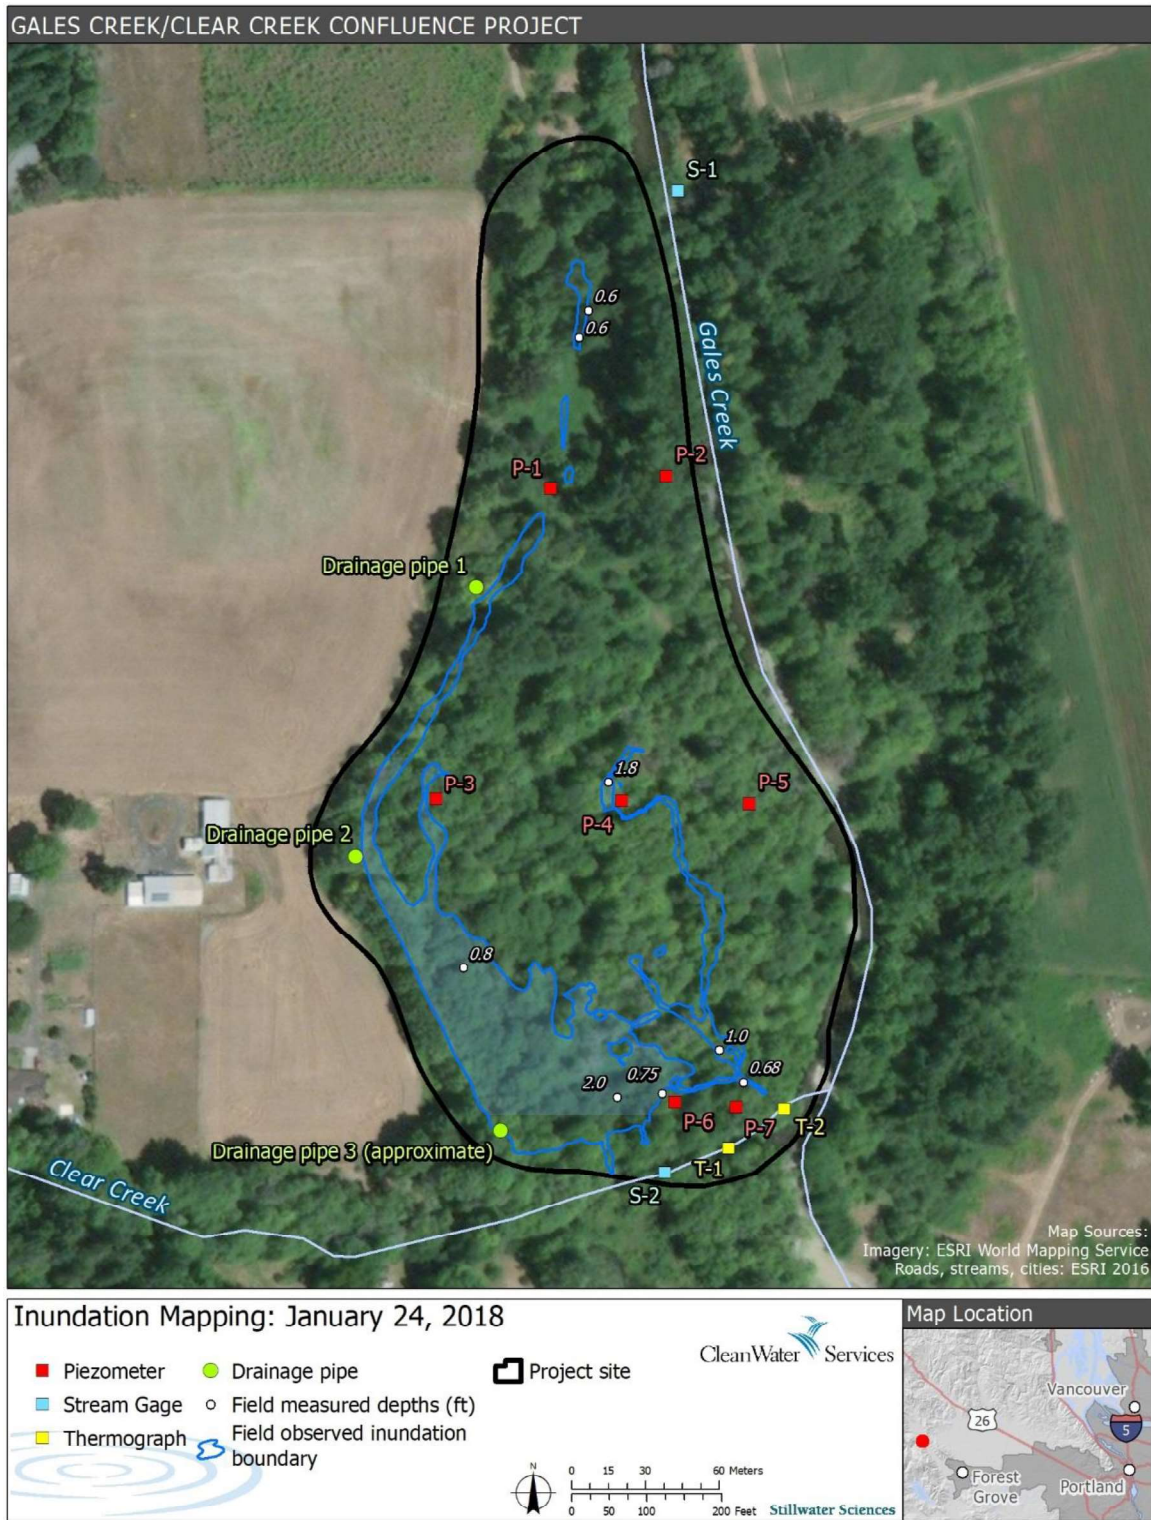
**Figure 16.** Map of field-based delineation of floodplain-inundation extent (polygons) and measurements of inundation depth (points) during wet-season conditions in January 2018 before enhancement construction.

Inundation extents during the wet-season mapping events in January 2018 and 2019 were much broader in the southwestern corner and extended farther north within two linear topographic depressions that are part of a historic ditch (Figure 16 and 17). The newly constructed side-channels were observed to be fully inundated and well connected with Gales Creek (near station T-2) during January 2019. Floodplain-inundation drainage to Gales Creek via the constructed side-channels was observed during the January 2019 mapping event and other field visits since construction. Evidence of surface-water flow through the notched dike was not observed, which indicates higher flows with a less frequent return period will be necessary to overtop the notched-dike invert and inundate the northern portion of the site floodplain.
