Lower Tualatin Watershed Analysis

**Washington County Soil and Water
Conservation District**

August 2001

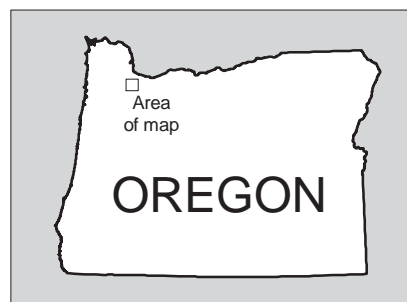
Map 1-3 -- Terrain elevation of the Lower Tualatin Watershed.

Data Sources: Elevation derived from 10-foot contours,
Metro (RLIS, 1997)

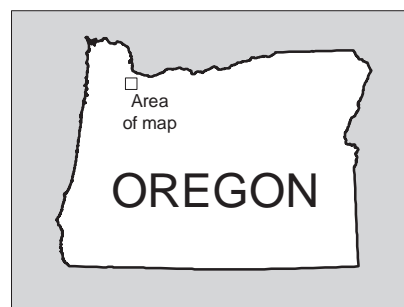
Map 3-6 -- Land Use and Land Cover in the Lower Tualatin Watershed.

Data Sources: ODFW 1997 and BLM 1998
