# Reach CL01

## Reach CL01

### Existing Conditions

## 4-4 Projects for Consideration

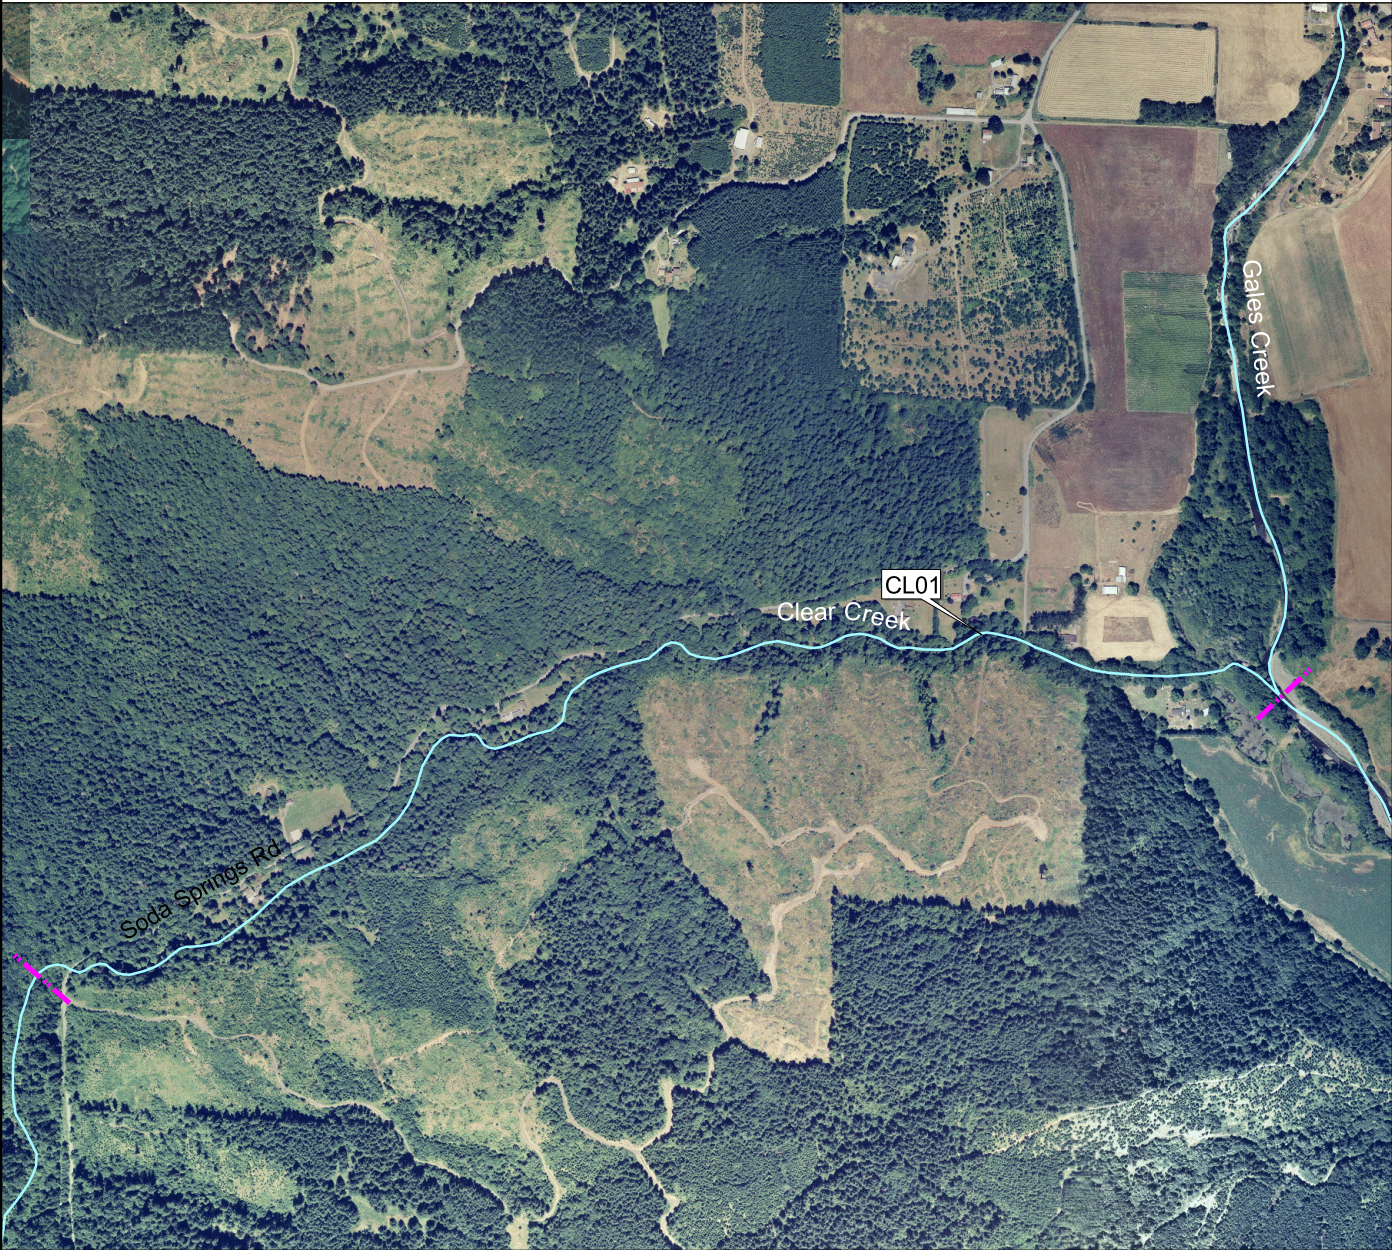
**Looking from Soda Springs Road Bridge downstream on Clear Creek. A water supply line is shown exposed in the bed of the stream channel. The line may cause a passage barrier during certain flow conditions. Results from a preliminary investigation indicate the line has been abandoned.**

- Fish Barriers – Evaluate potential fish barrier to determine if it is a barrier during all of the salmonids life cycle.

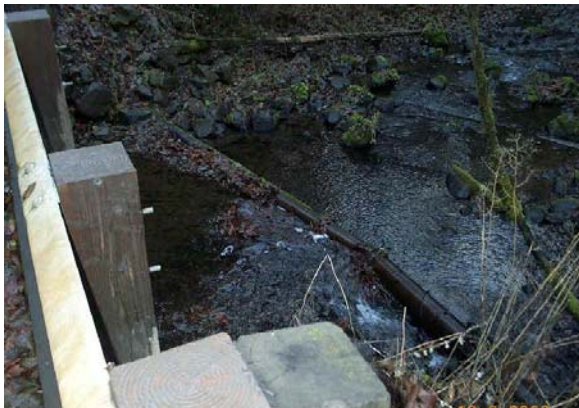
**Photo CL01-1**

- *Habitat Access:* There is a water supply line that crosses the stream channel about 15 feet downstream of the Soda Springs Road bridge that crosses over Clear Creek. It appears that it has been abandoned, since it is fully exposed to stream flow. It appears that it may be an impediment to juvenile fish passage. Upstream of the reach, within the City of Forest Grove water supply basin, the City's diversion structure on the Clear Creek fork is an existing fish passage barrier. The City is currently in the process of hiring a consultant/contractor to install fish passage at this location. There is another fish barrier at a large debris jam, approximately .8 miles upstream of the Forest Grove diversion.

1. Work with the City of Forest Grove to determine whether the water pipeline downstream of the Soda Springs Road Bridge is still in use. If it is not being used anymore, help to facilitate its removal.

The Project 9 priority area is located in Reach CL01. This project will involve working with the City of Forest Grove to determine whether the water pipeline downstream of the Soda Springs Road Bridge is still in use. This pipeline forms a potential barrier to juvenile passage. If it is not being used anymore, the project will help to facilitate its removal.

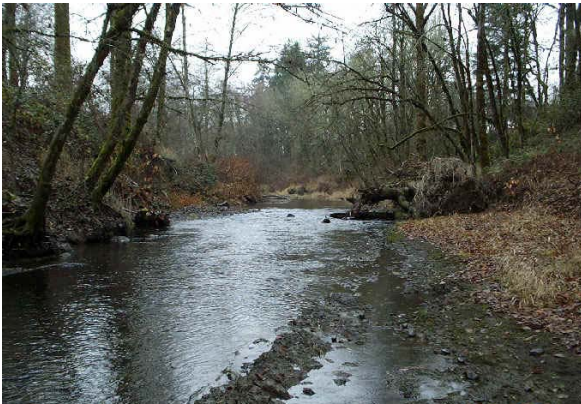
**Looking upstream (north) from the Roderick Road Bridge. The bed has been scoured down to cemented sandstone in most of the reach. Also, the channel lacks LWD. Intact riparian forest areas exist along both banks.**

Project 3 is located in Reach GL05. This project provides opportunities to increase in-stream complexity of the channel through the placement of LWD. This work should be completed all along the reach so that small pools and riffles form and provide habitat diversity. The wood will have to be well anchored due to the

confined nature of the channel and the related high flow velocities. Specific location for structures and methods to anchor the wood will be determined during the project design phase.

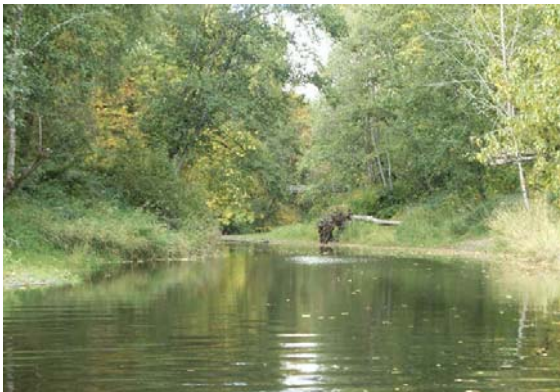
**Looking upstream (north) in the vicinity of the property owned by Washington County. This photo shows a glide with deciduous trees along the stream channel.**

Project 4 is located in Reach GL06. This project proposes to work with Washington County to determine the status of the conservation easement for the significant riparian area along the left bank. After the status of the easement is confirmed, develop an agreement with the County to either terrace back the left bank to enhance the floodplain or create a backwater channel in order to provide refuge for fish during high flow conditions. Existing riparian vegetation will be protected as much as possible and any impacted banks will be revegetated with native trees that will provide shade for the creek.

During the same project, there is an opportunity to increase the in-stream complexity of the channel through the placement of LWD. Wood in the stream could be used to back water up onto the floodplain, or into a backwater channel. Specific activities will be determined during the project design phase.

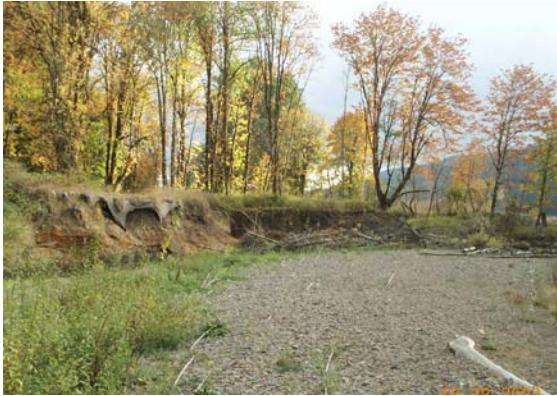
**Looking downstream (south) along Gales Creek. Bank erosion is evident on the outside bank. The height of the eroding bank is approximately 10 feet.**

Project 5 is located in Reach GL08. This project provides opportunities to work with a landowner to increase sinuosity of the channel along the left bank, upstream of the meander bend. This work would be completed to help reduce the energy being imparted on the outside bend, along the left bank.

Increasing the sinuosity would be beneficial by reducing flow velocities and forcing the channel to change directions, thus losing energy. There is a concern that additional erosion at the meander bend could cause the channel to short circuit the bend and straighten, thereby causing an increase in channel slope. This would potentially cause further instability of the channel. The project would be designed to reduce the potential of this occurring. Specific activities will be determined during the project design phase.

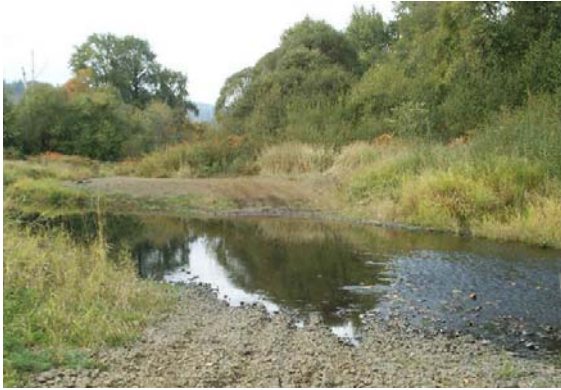
The Project 6 priority area is located in Reach GL09. This project entails working with the landowners to stop people from illegally driving in the stream. The main access point is located near the downstream end of the reach along the right bank and the driving extends to the middle of the reach. Either install a gate with lock if the landowner desires access to the edge of the creek, or place large boulders at the access point to prevent people from illegally accessing this area. Driving in the creek bed has adversely impacted the creek by causing the channel to widen, which has led to shallow summer flow depths.

**Looking upstream (northeast) along Gales Creek. The channel substrate and riparian vegetation in this reach have been impacted by vehicular traffic as shown.**

After the illegal access has been stopped, a project to increase the in-stream complexity of the channel through the placement of LWD would be constructed. This work should initially concentrate near the middle of the reach near the upstream end of where the illegal access occurred. The work would consist of creating areas with large wood and deep pools that fish can utilize for refuge from high water temperatures. Specific activities will be determined during the project design phase.

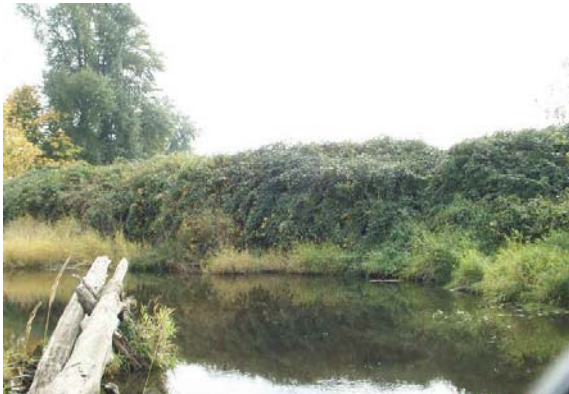
**Looking downstream (south) along Gales creek. The stream bank is covered with non-native species such as Himalayan blackberry and reed canarygrass.**

The Project 7 priority area is located in Reach GL10. This project involves working with landowners along the right bank to enhance and restore the riparian zone. This involves the removal of non-native species (mainly Himalayan blackberry) and planting of native vegetation.

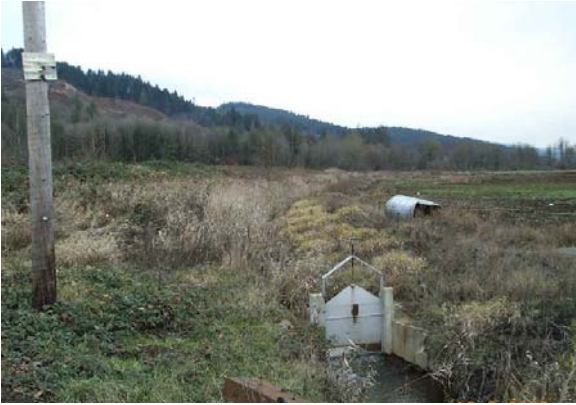
**Looking upstream (northwest) along Roderick Creek. A small sluice gate structure on the lower section of the creek may be a passage barrier. The reach lacks a sufficient cover of trees and shrubs to shade the channel.**

The Project 8 priority area is located in Roderick Creek, Reach RL02. This project involves working with the landowner along the left and right banks to enhance and restore the riparian zone. There is no existing riparian zone where the channel runs through the agricultural field. In this area, non-native vegetation would

be cleared from a 50-foot wide swath on either side of the creek. It would initially be planted with an erosion control mixture and then planted with native shrubs and trees.

In addition, work will be completed with ODFW to evaluate whether there truly is winter steelhead trout habitat upstream of the culvert that runs under the road and upstream of the sluice gate in the channel. If there is valuable fish habitat upstream of the culvert and the sluice gate and they are determined to be barriers to passage, there may be an opportunity to work with the landowner to mitigate the effects.
