Reach GL02, GL03, GL04

Reach GL02

Existing Conditions

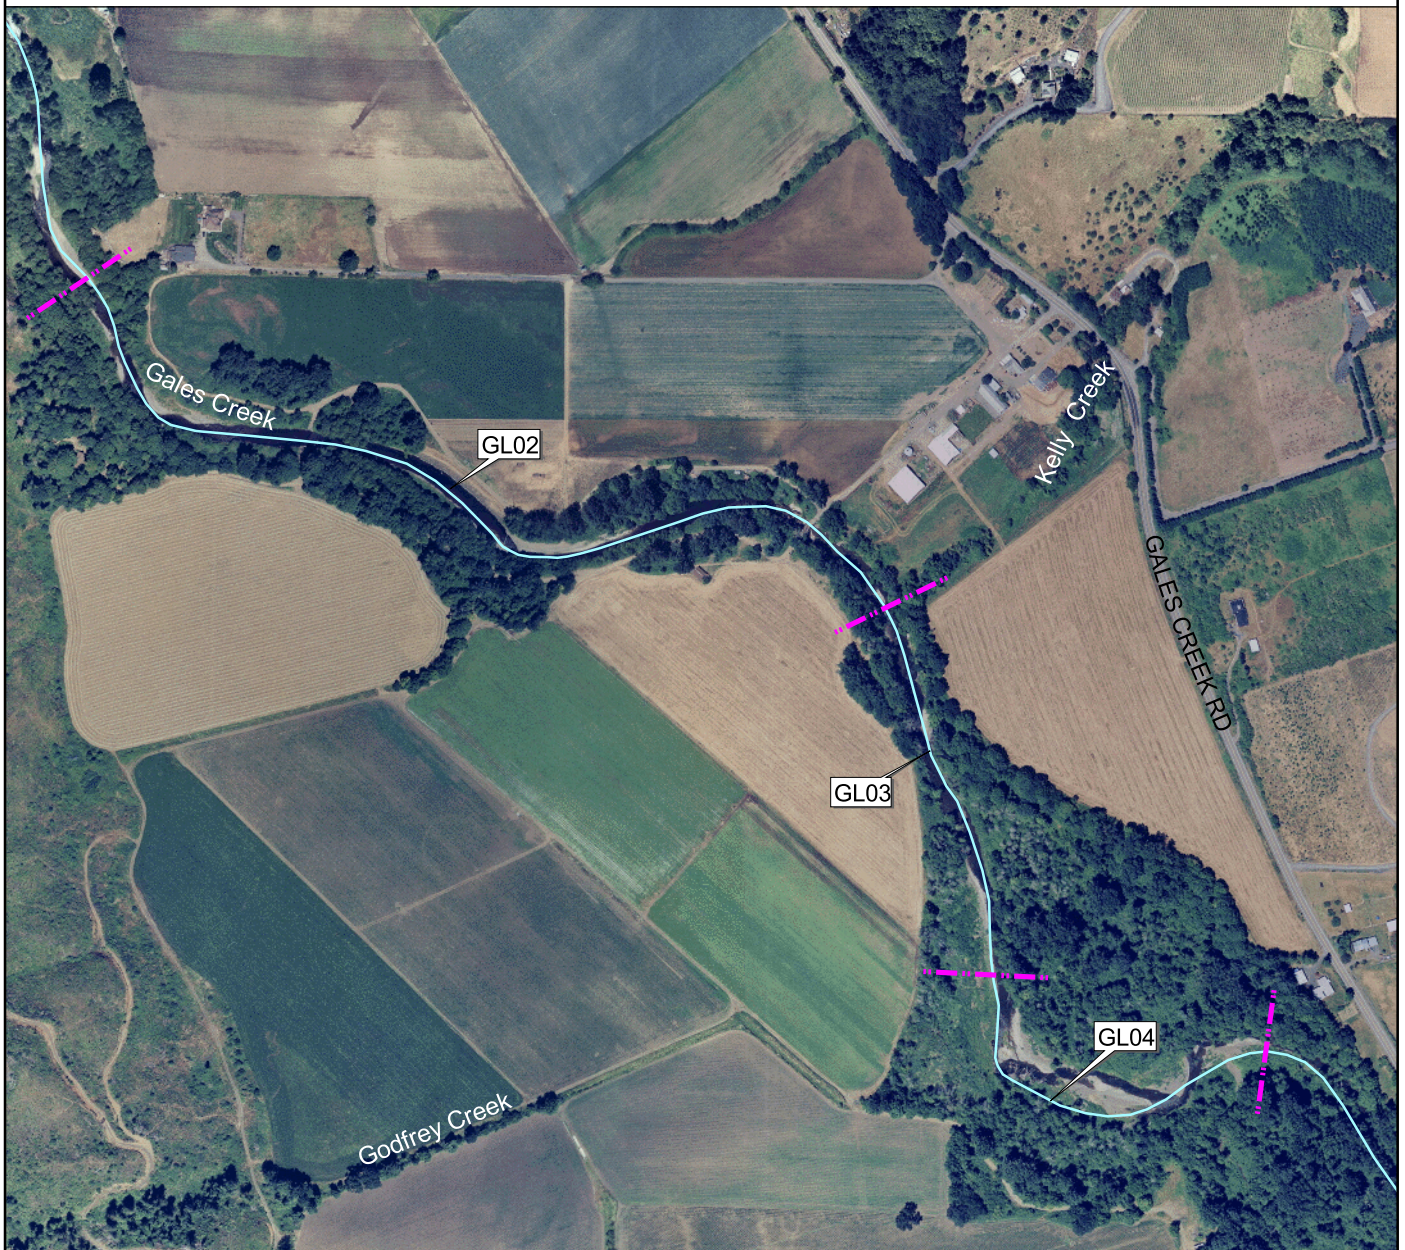
- *Channel Conditions:* The channel appears to be moderately confined, but it appears that flood flows may access low terraces along both the left and right banks during high flows that are greater than the bankfull flow. About 80 percent of the right and left banks have riprap protection. It is understood, through conversations with landowners, that some of the riprap was installed after the 1964 flood and some was installed after the 1996 flood. Near the middle of the reach, there is a farm road that runs right through the creek (no bridge). It's assumed this is only used during low flow periods. The channel location has not changed significantly between 1994 and 2002. The gradient of the stream within the reach is approximately 0.3 percent. The valley slope is approximately 0.5 percent

- *Riparian Conditions:* A majority of the riparian area is in moderate to poor condition with stands that are narrow and fragmented. The width varies from 0 feet to 250 feet. The stream runs west to east for a significant length of the reach. Much of the right bank (south side) has been protected with riprap. Some alders have grown through the riprap, but this is the only row of trees between the adjacent access road and the creek. There is very little effective shading along this approximately 800 foot stretch. There is approximately 500 foot stretch with no riparian vegetation along the left bank. This bank was protected with riprap after the 1996 flood.

- *Water Quality:* Temperature measurements taken at Roderick Road (the closest temp monitoring location to this reach) show that the largest diurnal temperature change, of any of the monitoring station along Gales Creek, occurred at Roderick Road. It appears likely that solar heating and a lack of riparian vegetation cause the high variability in daily temperatures. See Figure 4-1 for a comparison of diurnal temperatures at three monitoring stations along Gales Creek.

- *Water Quantity:* Five permitted water supply diversions exist along the reach. Two diversions were noted during the field visit. The ends of two of the diversion pipes were screened, but it is not known if the screening met ODFW screening criteria. Table 4-3 presents information for the following permitted diversions along the reach. All diversions are for irrigation (IR).
